## Summary Action Report

Structure ID: K-0009

<u>Structure Name:</u>	Big Bay Culvert	Bridge Condition Index (BCI): 29.6	
<u>Road Name:</u>	Big Bay Sideroad		
<u>Location:</u>	Lot 37/38 – Colpoj Range Keppel	<u>Inspection Date:</u>	June 3, 2024
<u>Structure Type:</u>	SPCSP Culvert	<u>Inspected By:</u>	Jesse Borges, P.Eng.
<u>No. of Spans:</u>	Single Span	<u>Spans Lengths:</u>	2.5m
<u>Road Width:</u>	6.5m	<u>Overall Structure Length:</u>	19.3m
<u>Year of Construction:</u>	1970	<u>Current Load Limit:</u>	N/A

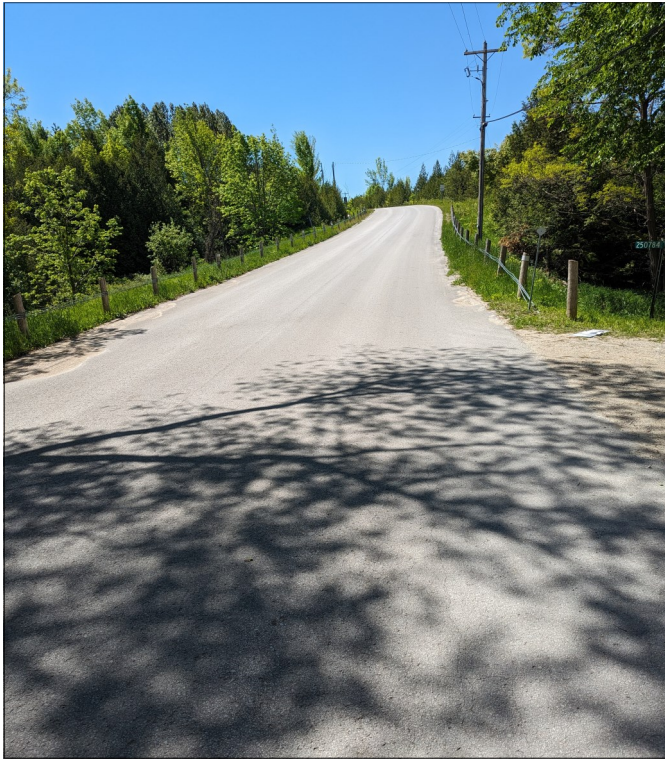
Photo 1 - View of Structure Facing South.

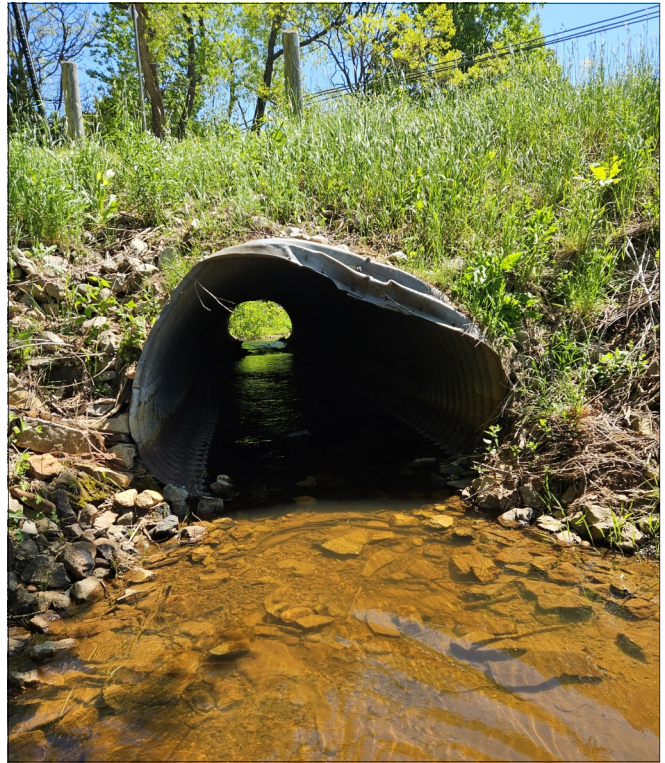
Photo 2 - View of West Culvert End.

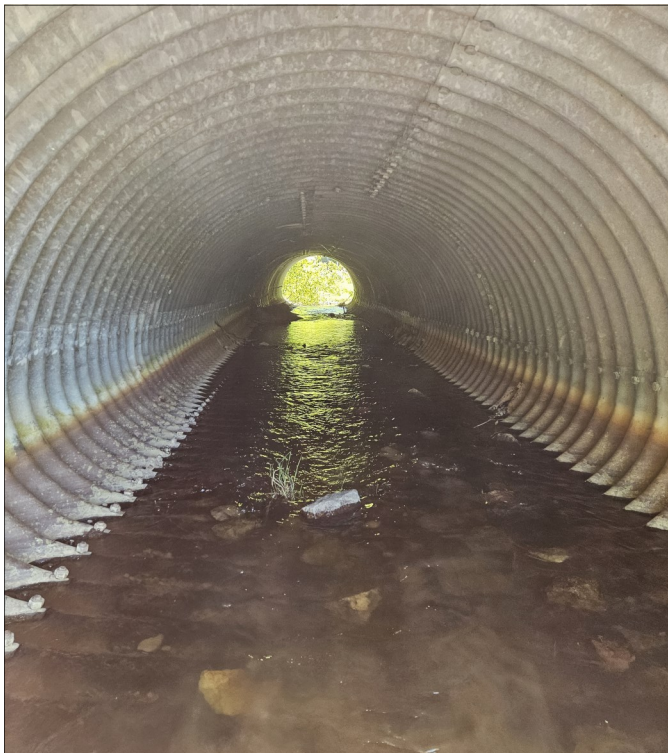
Photo 3 - View of Barrel Facing East.

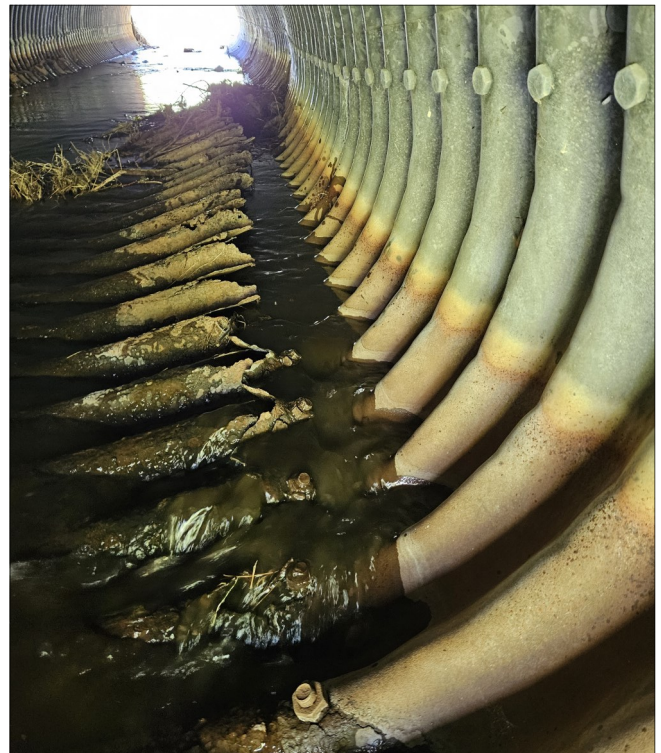
The structure appears to be in overall critical condition with large perforations and evidence of active overstressing of the culvert barrel walls. There are two large perforations noted at the north and south walls of the culvert. The north perforation measures 4.0m x 0.3m, which has caused the north wall of the barrel to settle and slip below the invert. Bolt hole cracking and crimping of the barrel corrugations was also noted along the south wall. Due to the presents of these deficiencies, the structure appears to be exhibiting buckling / failure issues and urgent replacement of the culvert (within 1 year) is recommended.

Photo 4 - View of Large Perforation on North Side of the Culvert.

Recommended Work:				Maintenance Needs:		None	
<input type="checkbox"/> Rehab <input checked="" type="checkbox"/> Replace <input checked="" type="checkbox"/> Urgent <input type="checkbox"/> 1-5 years <input type="checkbox"/> 6-10 years <input type="checkbox"/> None				<input type="checkbox"/> Urgent <input type="checkbox"/> 1 year <input type="checkbox"/> 2 year			
Recommend the replacement of the structure within 1 year.

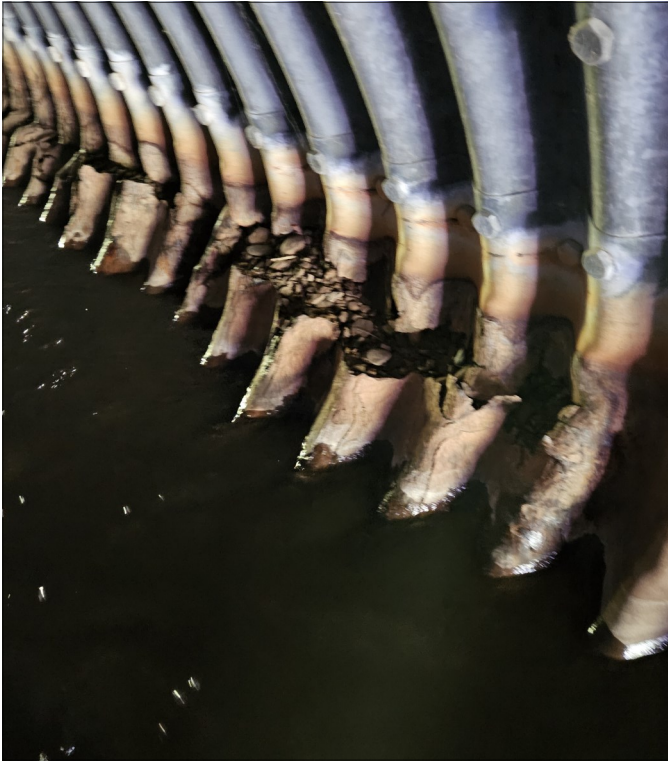
**Photo 5 - View of Large Perforation on South Side of the Culvert.**

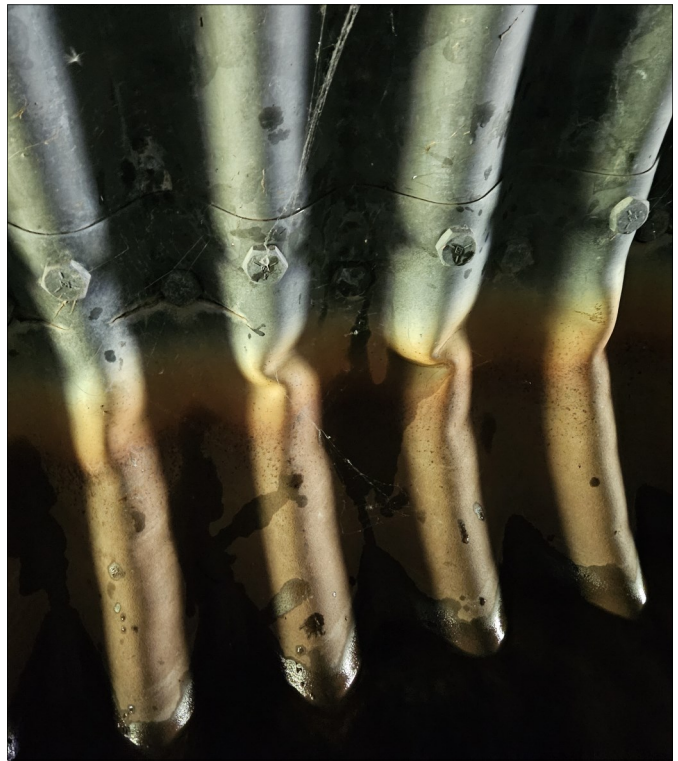
Replacement of the structure is recommended to ensure the safety of the public. The structure is exhibiting signs of overstressing and buckling which we anticipate will worsen over time with continued traffic use and further deterioration of the culvert barrel. This will also give the Township an opportunity to improve the safety of the roadway by installing a new steel beam guiderail system over the structure.

**Photo 6 - View of Local Buckling of Corrugations North Side of Barrel.**

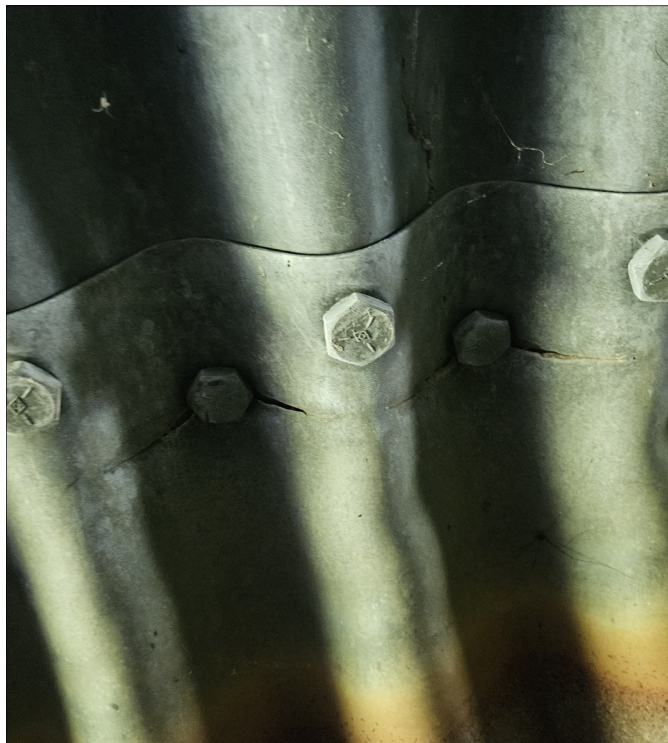
**Photo 7 - View of Bolt Hole Cracking on South Wall of Barrel.**

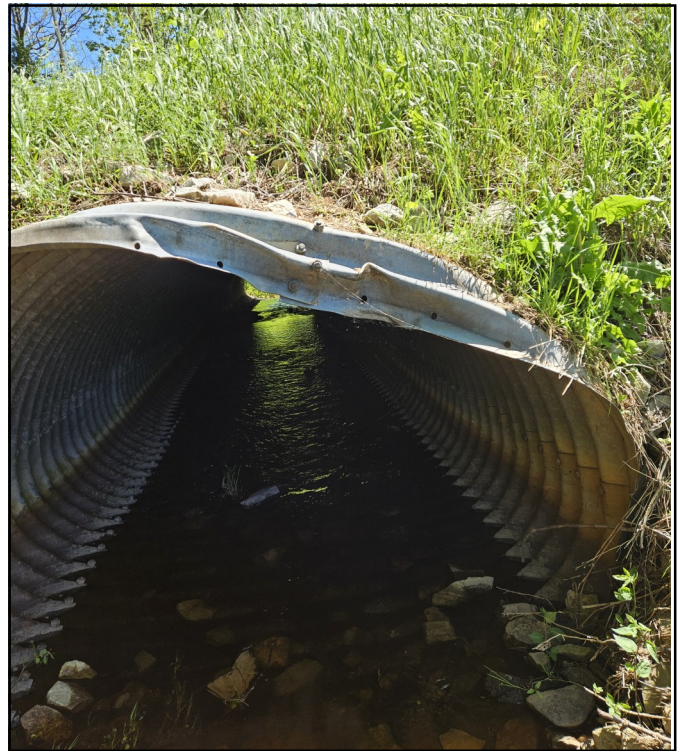
Element Group:		Culvert		Length:		19.3m	
Element Name:		Barrels		Width:		2.5m	
Location:				Height:		1.75m	
Material:		Corrugated Steel		Count:		1	
Element Type:		Multi- Plate Pipe		Total Quantity:		135m <sup>2</sup>	
Environment:		Benign / <b>Moderate</b> / Severe		Limited Inspection <input type="checkbox"/>			
Protection System:		Hot Dip Galvanizing				Perform. Deficiencies	
Condition	Units	Exc.	Good	Fair	Poor	Perform. Deficiencies	
Data:	m <sup>2</sup> / m / each / % / all				135	02	
<p>Comments: The barrel is in overall poor condition and requires urgent replacement. The culvert has a large perforation (4.0m x 0.2m) along the north wall of the barrel at mid-length. Due to the perforation, the north wall of the barrel is settling and beginning to slide beneath the invert. The culvert also has a large perforation (3.0m x 0.1m) along the south wall of the barrel at mid-length. The south wall of the barrel is also exhibiting bolt hole cracking at the mid bolt line and the adjacent corrugations are beginning to crimp (6.0m of barrel). The west end of the culvert has experienced impact damage reducing the hydraulic capacity of the structure.</p>

**Photo 8 - View of Damaged Invert — West End.**
