Summary Action Report

Structure ID: K-0021

Road Name: Kemble Rock Road

Structure Type: Double CSP Culvert

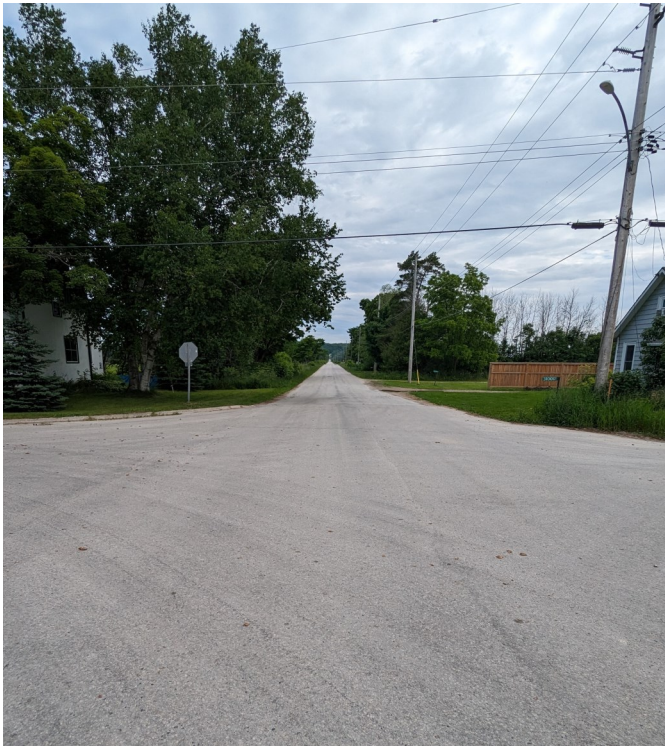
Photo 1 - View of Roadway Facing North.

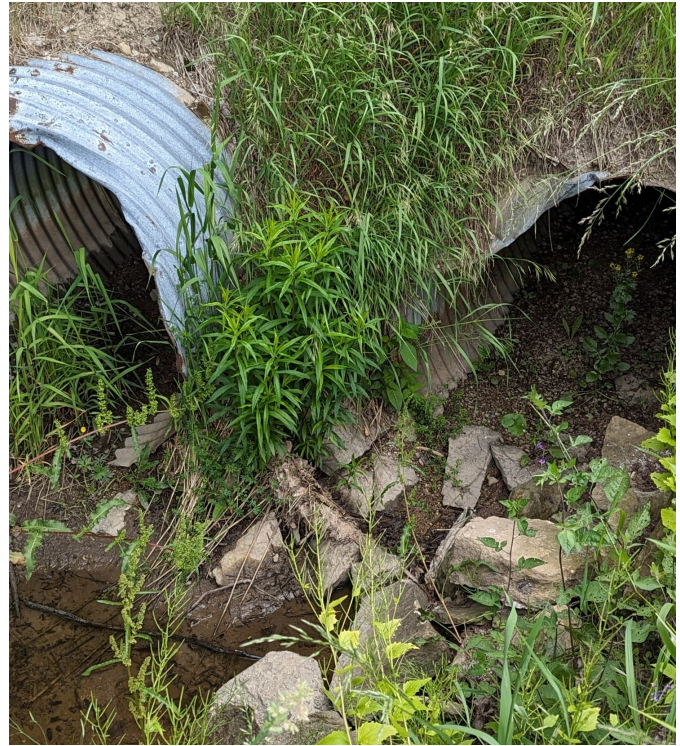
Photo 2 - View of Structure Facing East.

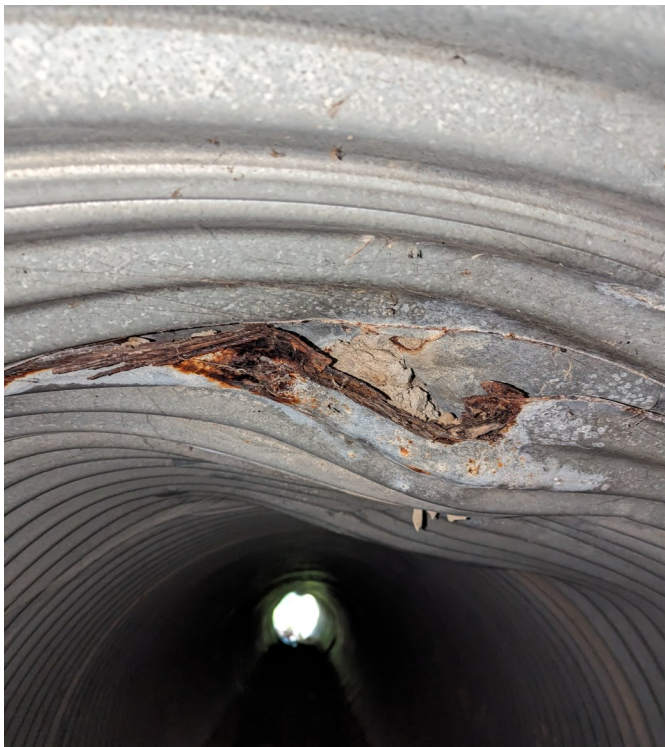
Element Group:		Culverts		Length:		46.5m	
Element Name:		Barrels		Width:		1.2m	
Location:		South Culvert		Height:		1.2	
Material:		Corrugated Steel		Count:		1	
Element Type:				Total Quantity:		175.3m ²	
Environment:		Benign / Moderate / Severe		Limited Inspection <input checked="" type="checkbox"/>			
Protection System:		Hot Dip Galvanizing					Perform. Deficiencies
Condition	Units		Exc.	Good	Fair	Poor	Perform. Deficiencies
Data:	m ² / m / each / % / all				105.2	70.1	02
Comments: The south barrel appears to be in fair to poor condition with moderate to severe corrosion noted along the invert. Perforations below water staining mark noted throughout including around storm pipe outlet connected to south barrel wall. Localized deformations and perforations at obvert noted. Limited inspection of barrel invert due to accumulation of debris and sediment within culvert.							
Recommended Work:				Maintenance Needs:		None

Photo 3 - View of Large Deformation at South Barrel Obvert.

<input type="checkbox"/> Rehab <input checked="" type="checkbox"/> Replace <input checked="" type="checkbox"/> Urgent <input type="checkbox"/> 1-5 years <input type="checkbox"/> 6-10 years <input type="checkbox"/> None				<input type="checkbox"/> Urgent <input type="checkbox"/> 1 year <input type="checkbox"/> 2 year			
Recommend the replacement of the structure within 1 year.

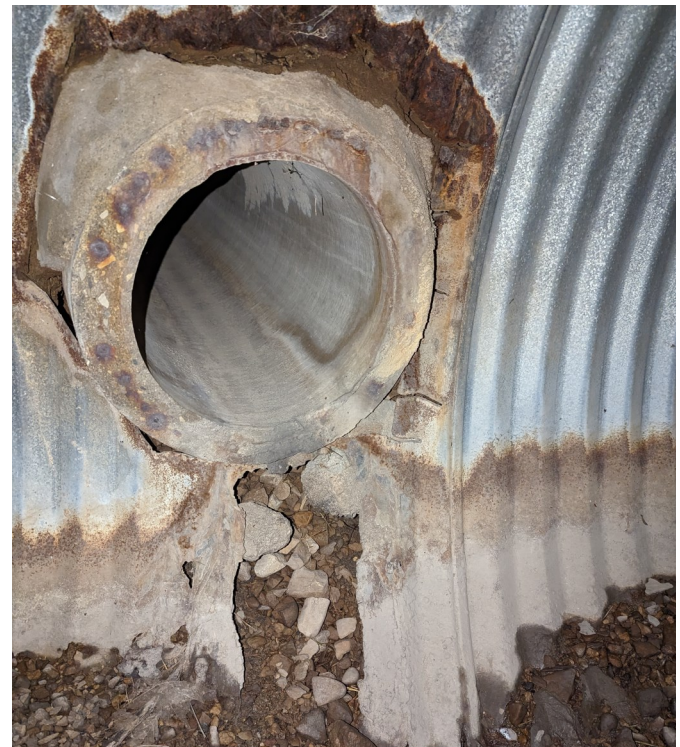
Photo 4 - View of Barrel Deterioration at Storm Pipe Connection for South Barrel.

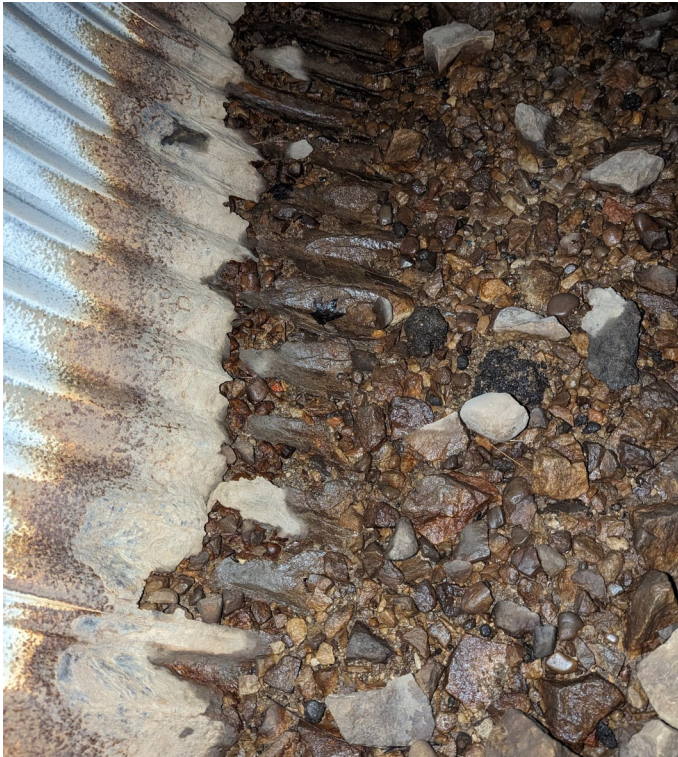
Photo 5 - View of Excessive Perforations at South Barrel Invert (Typ.)

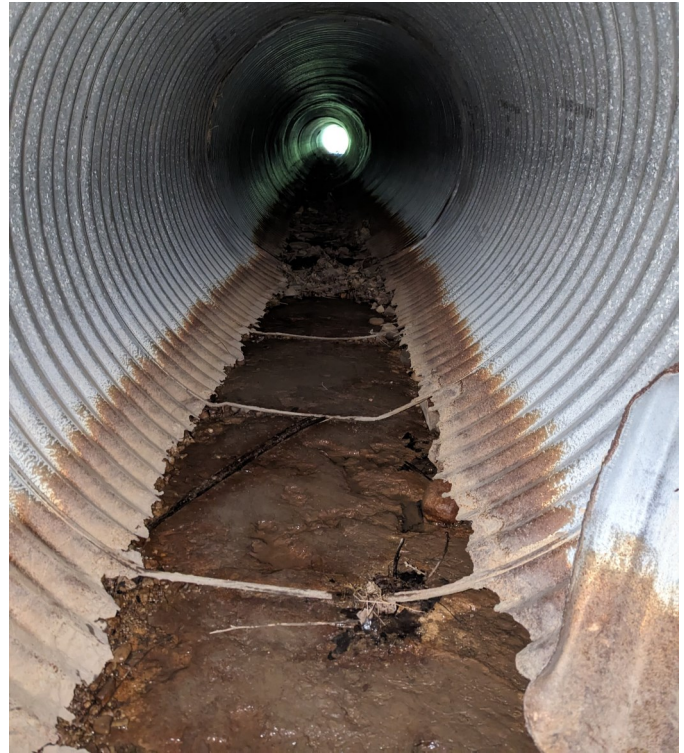
Element Group:		Culverts		Length:		46.5m	
Element Name:		Barrels		Width:		1.2m	
Location:		North Culvert		Height:		1.2	
Material:		Corrugated Steel		Count:		1	
Element Type:				Total Quantity:		175.3m	
Environment:		Benign / Moderate / Severe		Limited Inspection <input checked="" type="checkbox"/>			
Protection System:		Hot Dip Galvanizing					Perform. Deficiencies
Condition	Units		Exc.	Good	Fair	Poor	Perform. Deficiencies
Data:	m ² / m / each / % / all				70.1	105.2	02
Comments: The north barrel appears to be in fair to poor condition with large deformations at the obvert noted throughout ranging from 0.1m to 0.3m in deflection. Separation noted at every barrel joint ranging from 0.1m – 0.2m. Large perforations along invert as caused complete separation of the barrel walls.							
Recommended Work:				Maintenance Needs:		None	
<input type="checkbox"/> Rehab <input checked="" type="checkbox"/> Replace <input checked="" type="checkbox"/> Urgent <input type="checkbox"/> 1-5 years <input type="checkbox"/> 6-10 years <input type="checkbox"/> None				<input type="checkbox"/> Urgent <input type="checkbox"/> 1 year <input type="checkbox"/> 2 year

Photo 6 - View of Severe Section Loss at North Barrel Invert.

Recommend the replacement of the structure within 1 year.

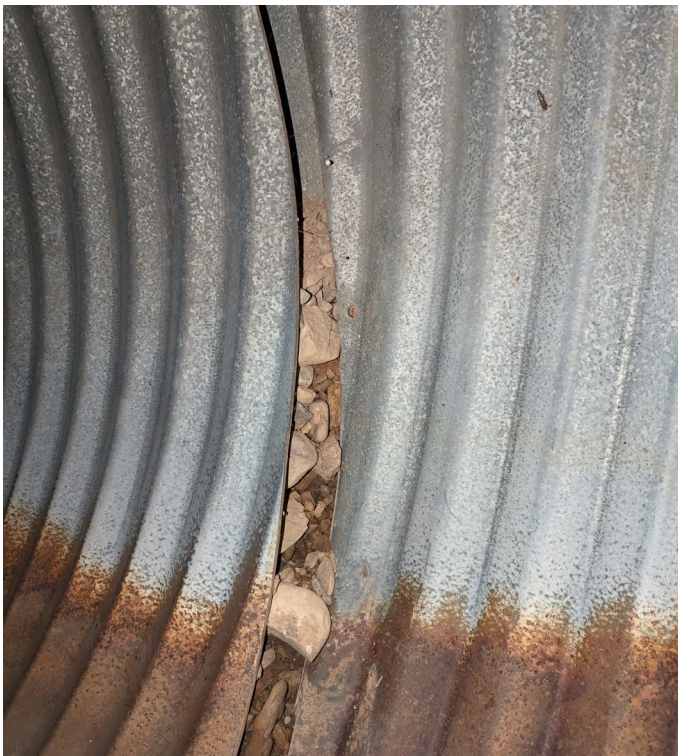
Photo 7 - View of Joint Separation at North Barrel (Typ.)

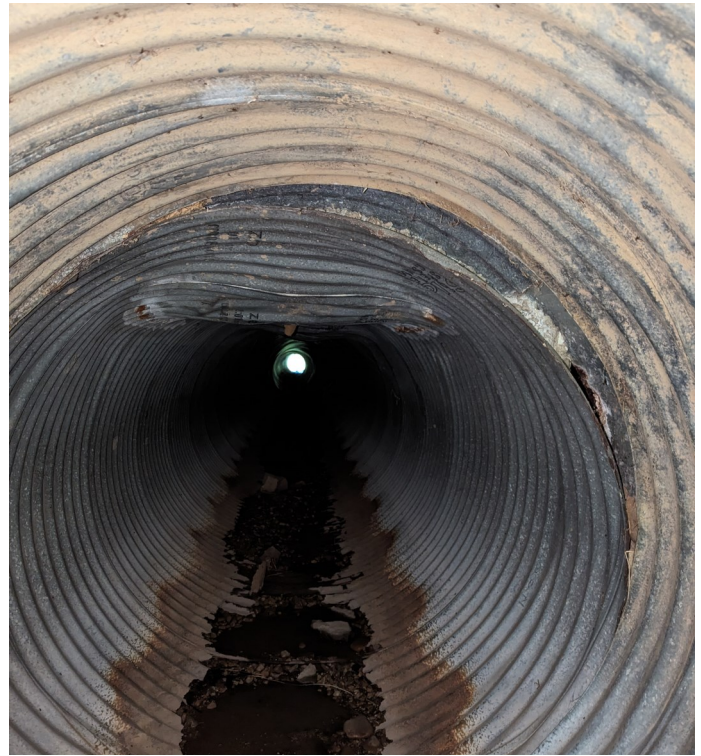
Photo 8 - View of Large Deformations at North Barrel Obvert (Typ.)

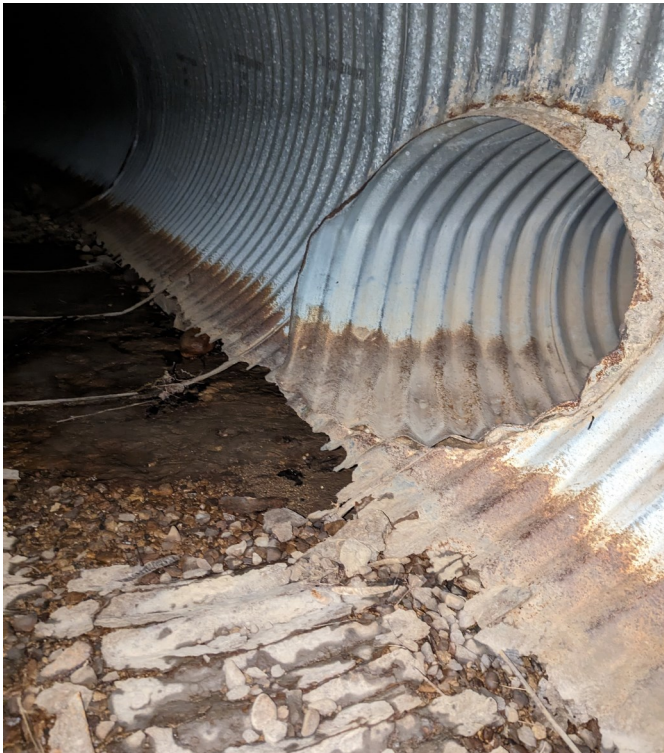
Photo 9 - View of Storm Pipe Connection at North Barrel.

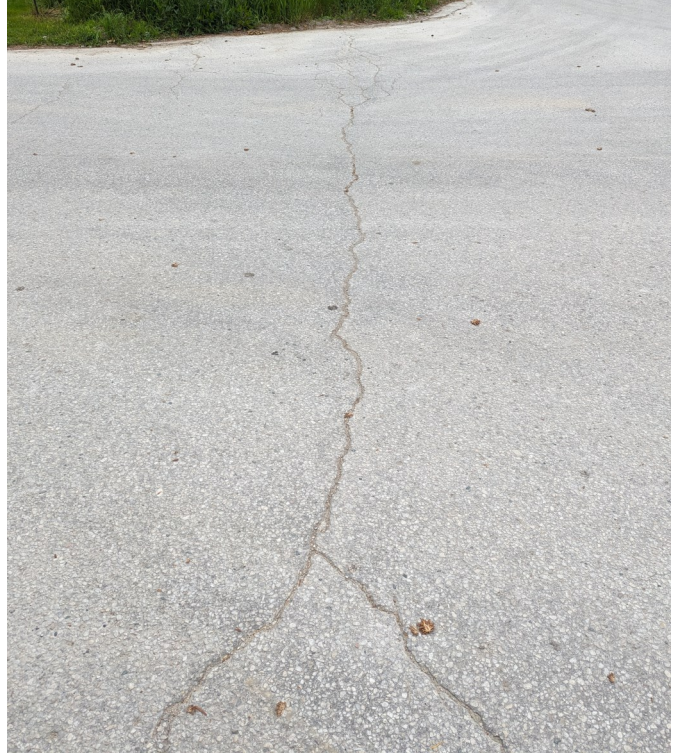
Element Group:		Decks		Length:		6.5m	
Element Name:		Wearing Surface		Width:		2.8m	
Location:		Deck Top		Height:			
Material:		Asphalt		Count:		1	
Element Type:				Total Quantity:		18.2m ²	
Environment:		Benign / Moderate / Severe		Limited Inspection <input type="checkbox"/>			
Protection System:							Perform. Deficiencies
Condition Data:	Units	Exc.	Good	Fair	Poor	Perform. Deficiencies	
	m ² / m / each / % / all		15.2	1.5	1.5	None	
Comments: The asphalt wearing surface appears to be in overall good to fair condition. 3.5m ² of medium map cracking noted at southeast. 11m medium transverse cracking noted above culvert.							
Recommended Work: <input type="checkbox"/> Rehab <input checked="" type="checkbox"/> Replace				Maintenance Needs:		None	
<input checked="" type="checkbox"/> Urgent <input type="checkbox"/> 1-5 years <input type="checkbox"/> 6-10 years <input type="checkbox"/> None				<input type="checkbox"/> Urgent <input type="checkbox"/> 1 year <input type="checkbox"/> 2 year

Photo 10 - View of Transverse Cracking in Wearing Surface Over Structure.

Wearing surface will be replaced during the culvert replacement. Costed under Approach Element.

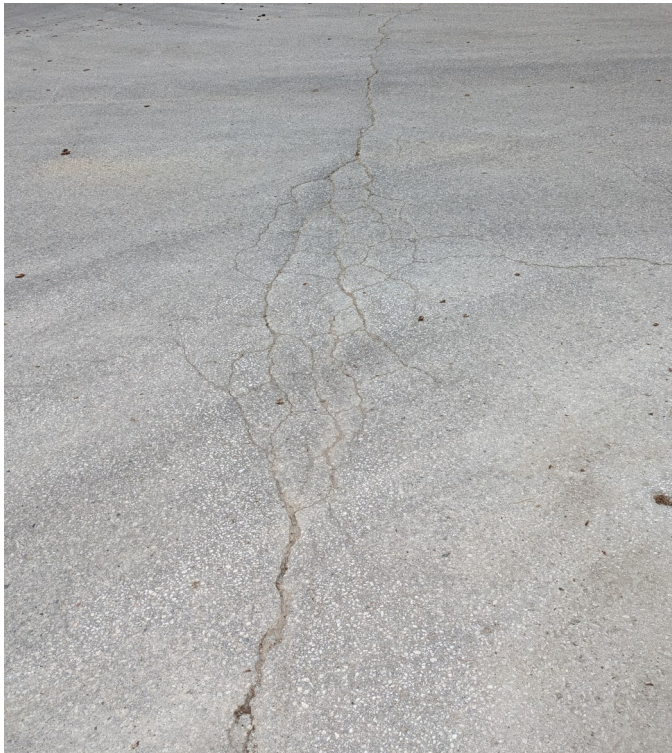
Photo 11 - View of Map Cracking in Wearing Surface Over Structure.

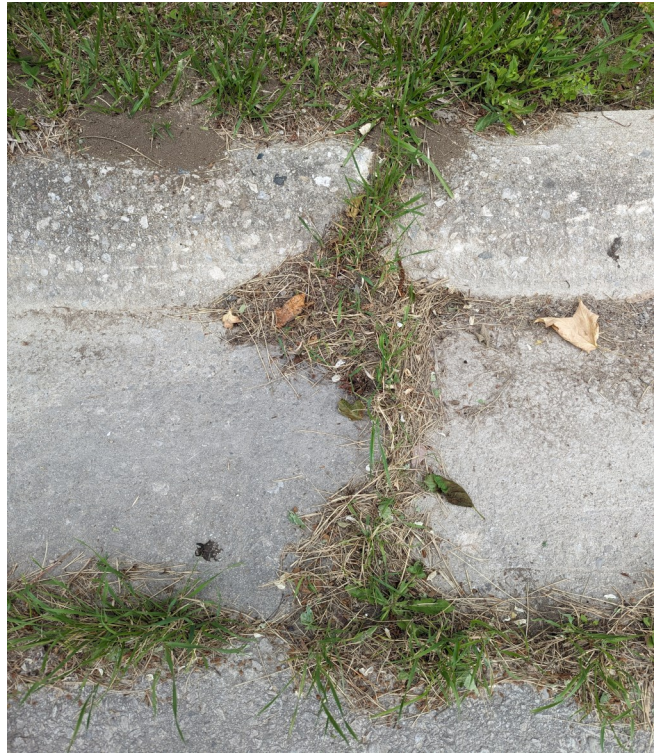
Element Group:		Sidewalks/Curbs		Length:		36m	
Element Name:		Curbs		Width:		0.7m	
Location:		Each Side		Height:		0.15m	
Material:		Concrete		Count:		1	
Element Type:		Reinforced Concrete		Total Quantity:		36.0m	
Environment:		Benign / Moderate / Severe		Limited Inspection <input type="checkbox"/>			
Protection System:							Perform. Deficiencies
Condition	Units		Exc.	Good	Fair	Poor	Perform. Deficiencies
Data:	m ² / m / each / % / all			28.8	3.6	3.6	None
Comments: Mountable curb on west side appears to be in overall good condition. Multiple transverse medium to wide cracks noted in curb throughout length.							
Recommended Work: <input type="checkbox"/> Rehab <input checked="" type="checkbox"/> Replace <input checked="" type="checkbox"/> Urgent <input type="checkbox"/> 1-5 years <input type="checkbox"/> 6-10 years <input type="checkbox"/> None				Maintenance Needs:		None	
				<input type="checkbox"/> Urgent <input type="checkbox"/> 1 year <input type="checkbox"/> 2 year

Photo 12 - View of Transverse Crack in Curb (Typ.)

Curbs will be replaced during the culvert replacement.
