## Summary Action Report

Structure ID: S-0005

Structure Name: Townline Trail Bridge

Inspection Date: 06/12/2024

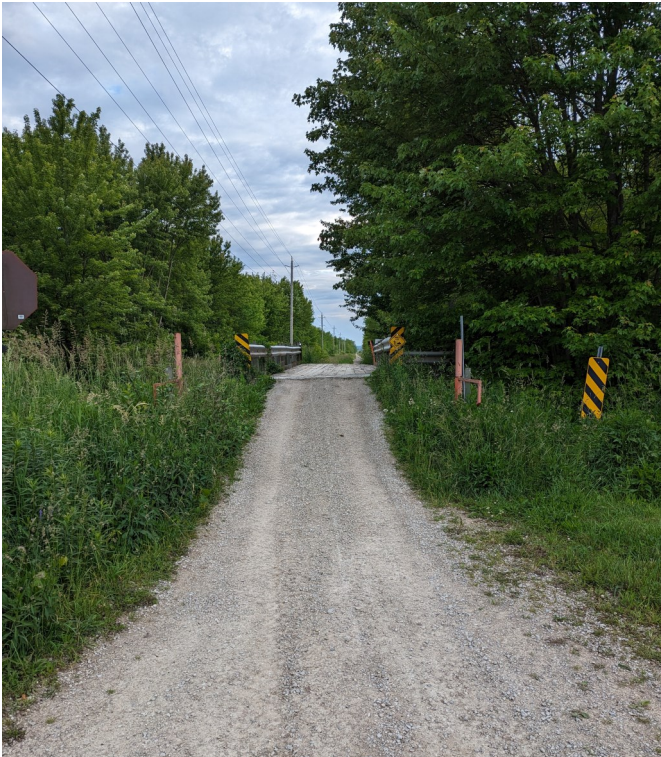
Photo 1 - View of Structure Facing North.

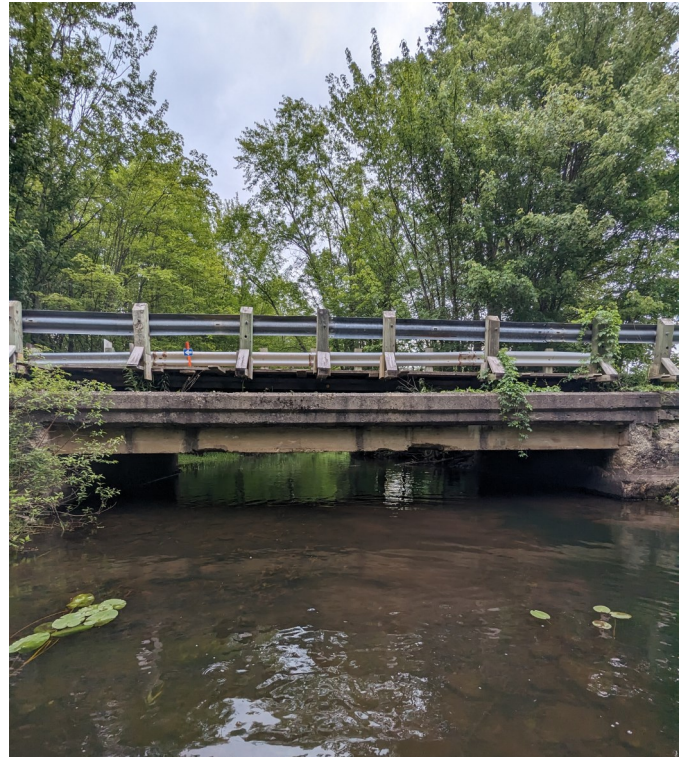
Photo 2 - View of Structure Facing East.

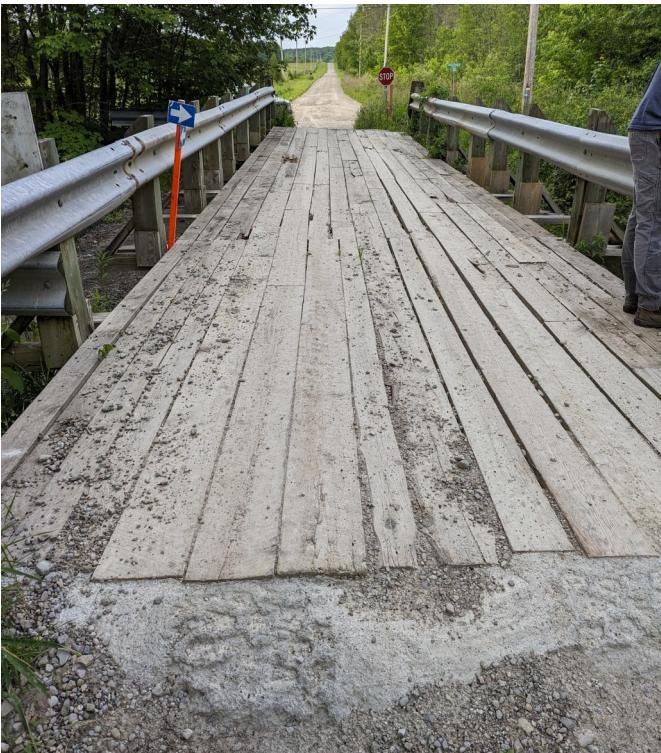
Photo 3 - View of Deck Top (Upper Structure) Facing South.

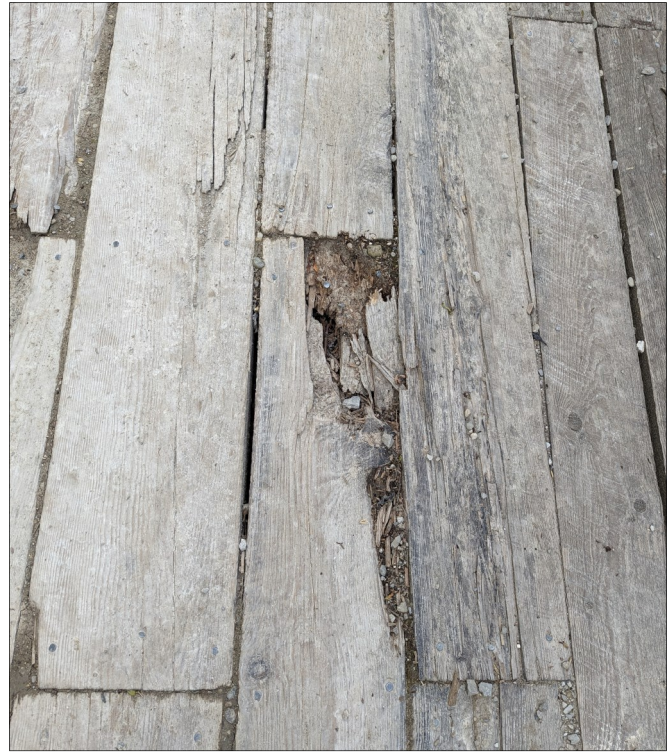
Photo 4 - View of Rotten Deck boards (typ.).

If rehabilitation is considered as the preferred alternative, reconstruct bridge deck.

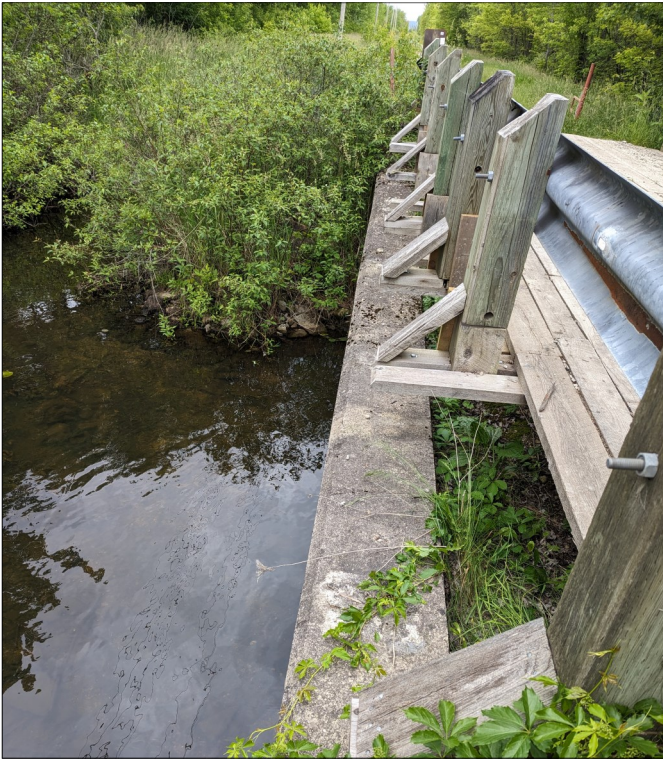
Photo 5 - View of Barrier System (typ.).

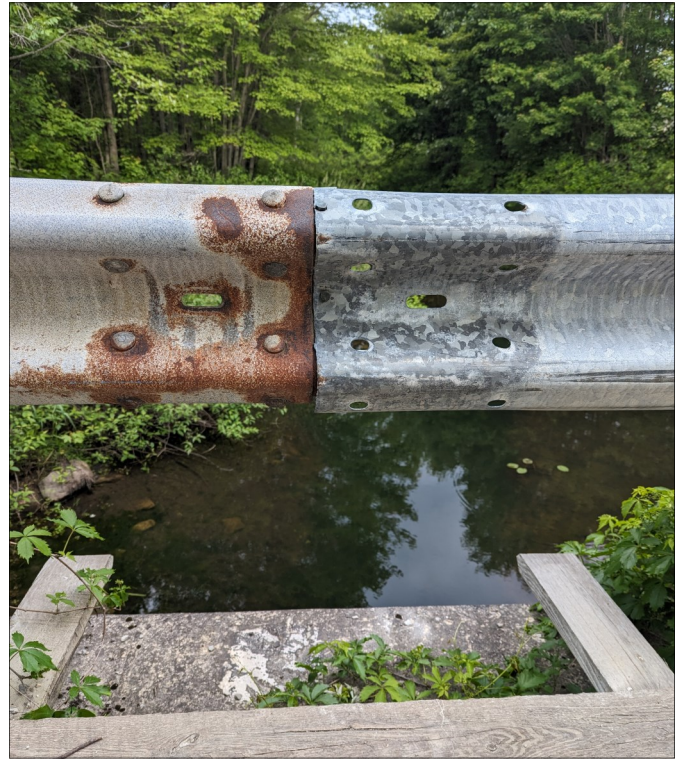
29.10
			Perform. Deficiencies
			01
Comments: Material of steel beam guiderail barrier appears to be in overall good condition, but the splice connections do not appear to be code compliant at four locations. Due to improper splice connections, barrier does not provide adequate safety for vehicles. Minor surface corrosion noted throughout.			
Recommended Work:	<input type="checkbox"/> Rehab <input checked="" type="checkbox"/> Replace		Maintenance Needs:
	<input checked="" type="checkbox"/> Urgent <input type="checkbox"/> 1-5 years <input type="checkbox"/> 6-10 years <input type="checkbox"/> None		None
If rehabilitation is considered as the preferred alternative, reconstruct barrier system.		<input type="checkbox"/> Urgent <input type="checkbox"/> 1 year <input type="checkbox"/> 2 year

Photo 6 - View of Improper Barrier Lap Splice (typ.).

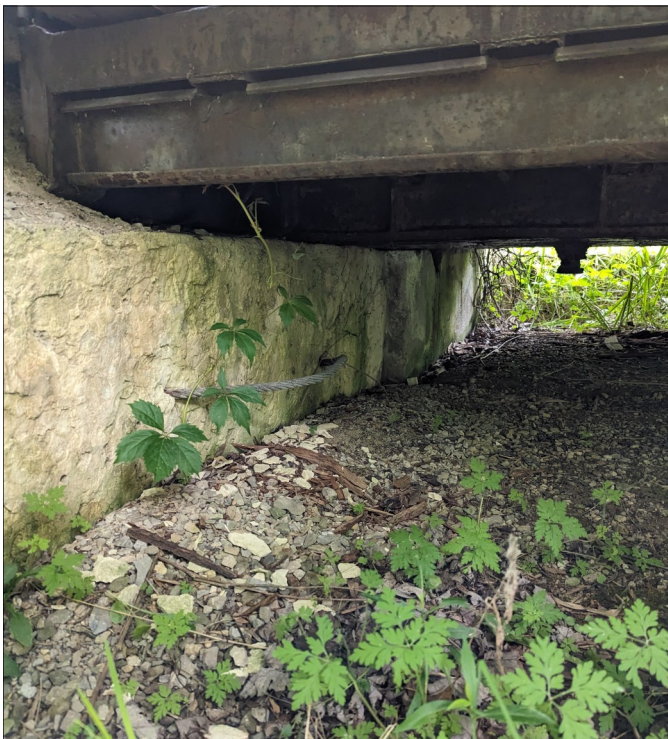
Photo 7 - View Upper Structure Abutment Wall.

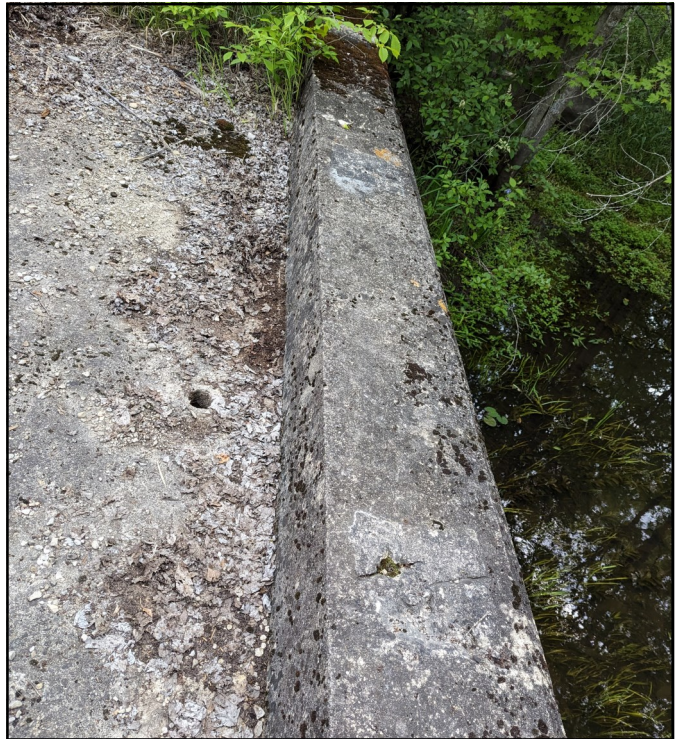
Photo 8 - View of Exposed Portion of Lower Structure Deck Top and Curb.

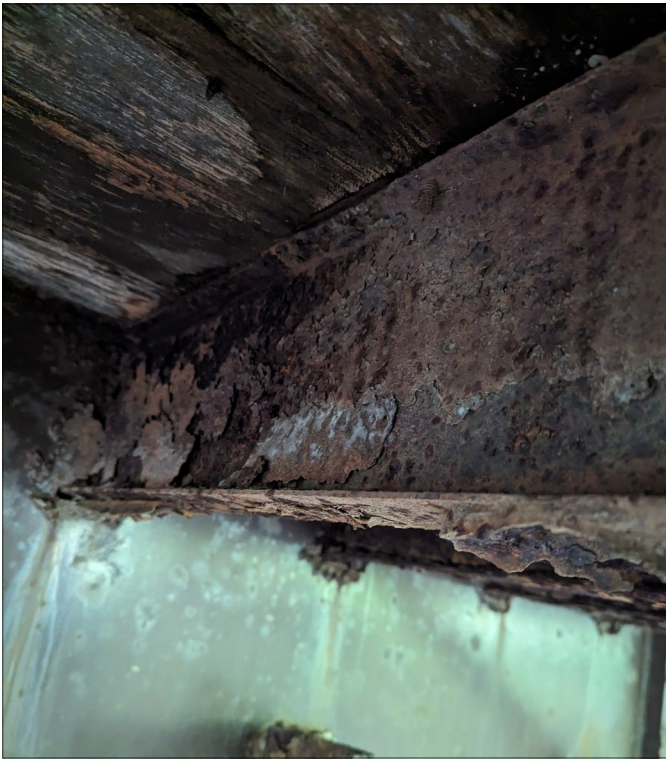
**Photo 9 - View of Extensive Light to Medium Corrosion of Steel Stringers.**

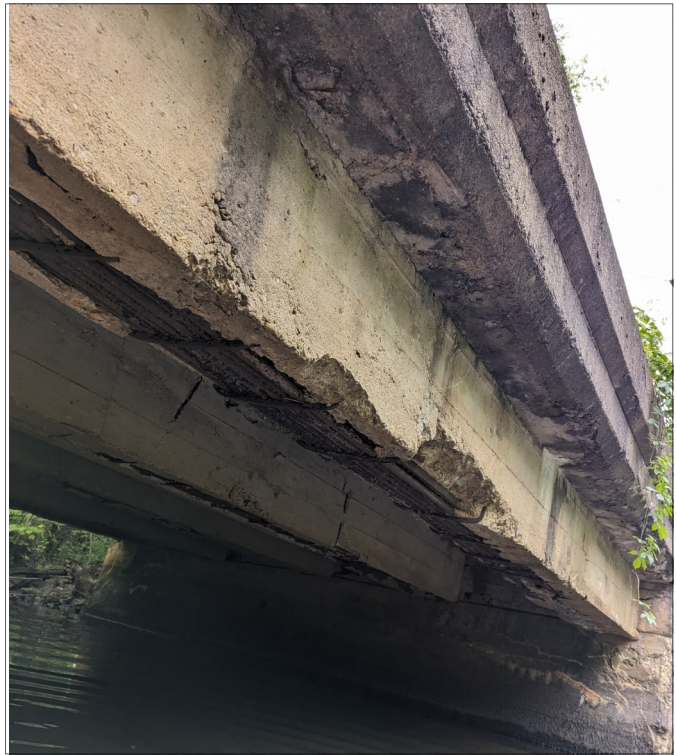
**Photo 10 - View of Underside of Lower Structure.**

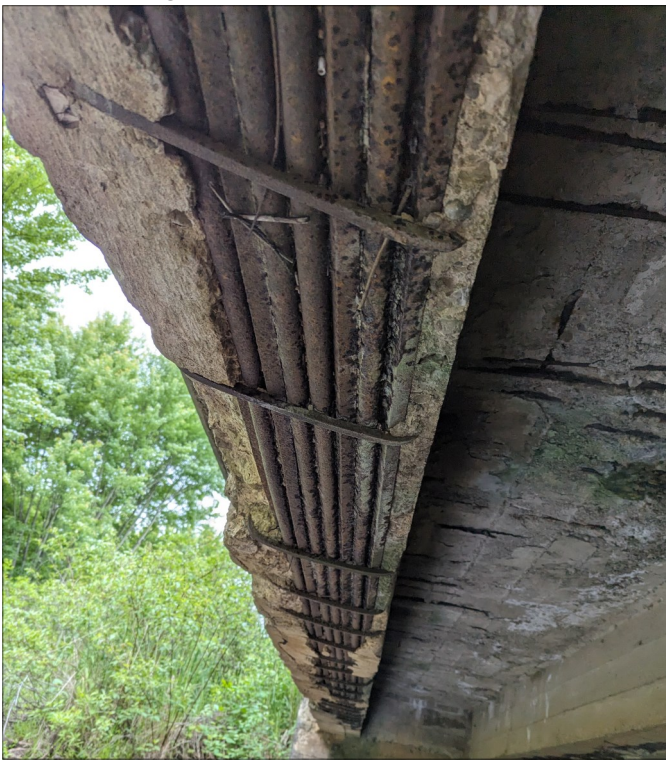
**Photo 11 - View of Exposed Reinforcing Below Exterior Concrete Girder.**

If bridge structure is permanently closed, recommend removing original structure.

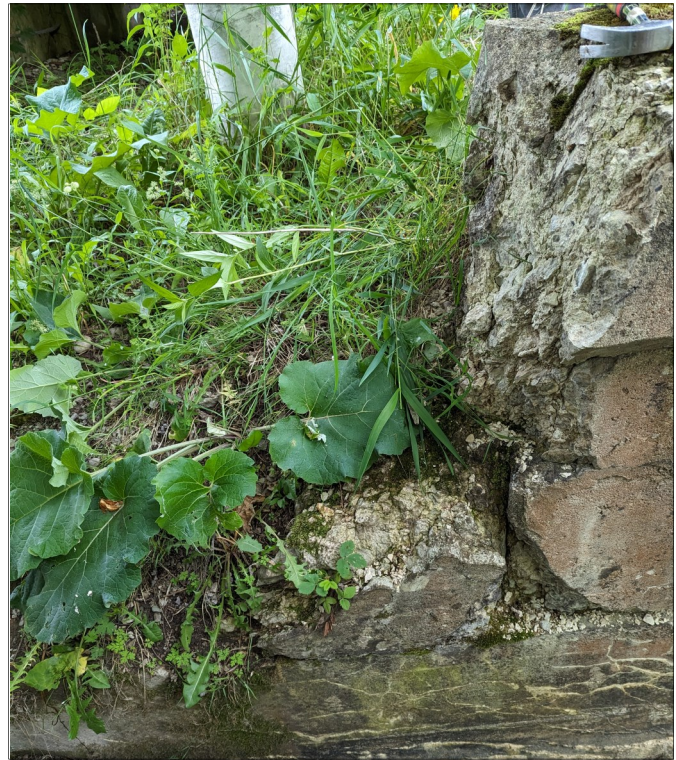
**Photo 12 - View of Broken Section of Southeast Wingwall.**

<input type="checkbox"/> Urgent <input checked="" type="checkbox"/> 1-5 years <input type="checkbox"/> 6-10 years <input type="checkbox"/> None		<input type="checkbox"/> Urgent <input type="checkbox"/> 1 year <input type="checkbox"/> 2 year
If bridge structure is permanently closed, recommend removing original structure.

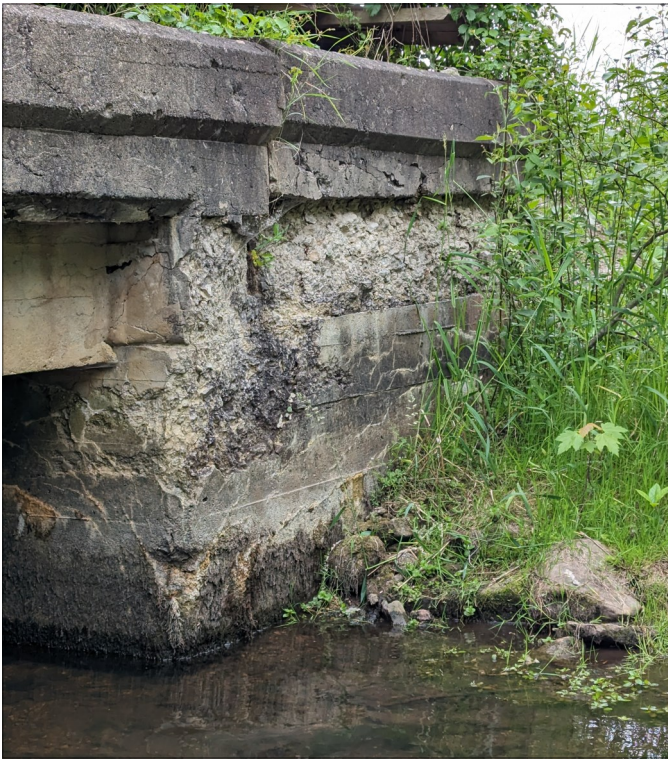
Photo 13 - View of Deteriorated Wingwall at Northeast.

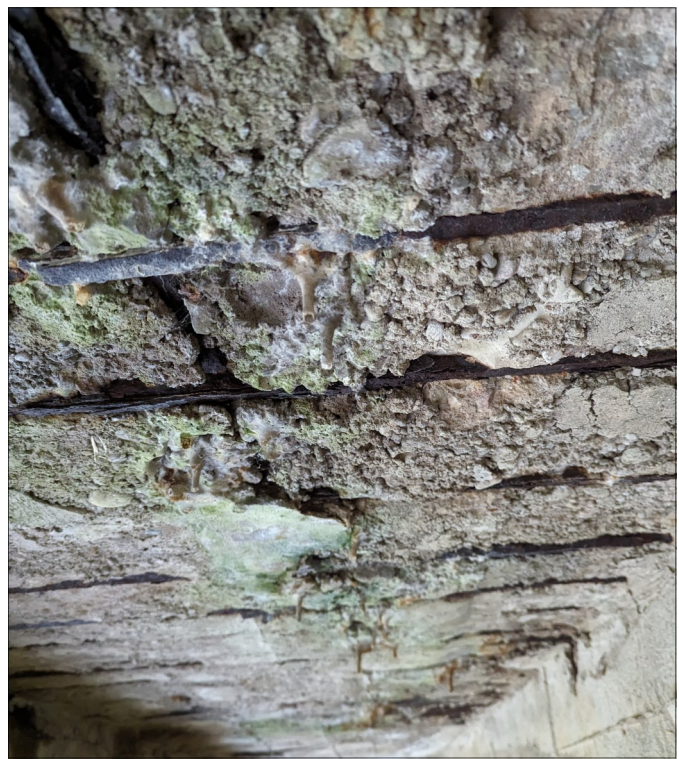
Photo 14 - Evidence of Water Penetration Through Original Deck Top.

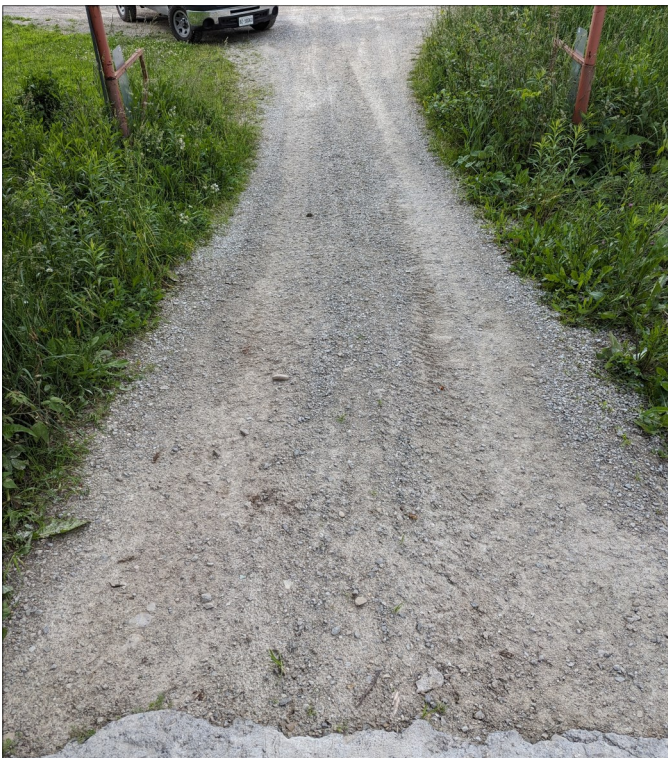
Photo 15 - View of Steep Gravel Approach.

If rehabilitation is considered as the preferred alternative, consider re-grading approaches.

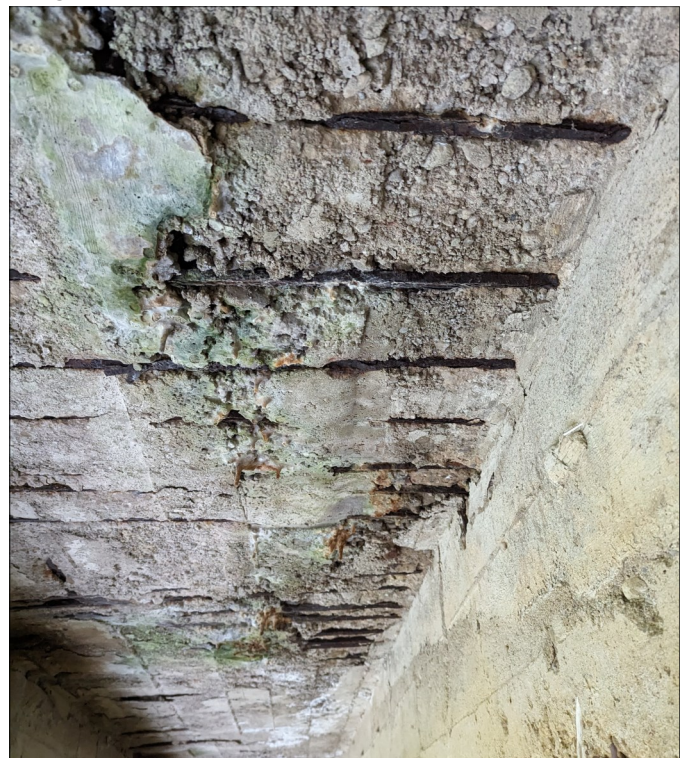
Photo 16 - View of Exposed Reinforcing at Interior Soffit.

If bridge structure is permanently closed, recommend removing original structure.
