# TOWNLIN TRAIL BRIDGE (S-0005) LOAD EVALUATION REPORT

THE TOWNSHIP OF GEORGIAN BLUFFS

February 2025  
Project No. 24017.01

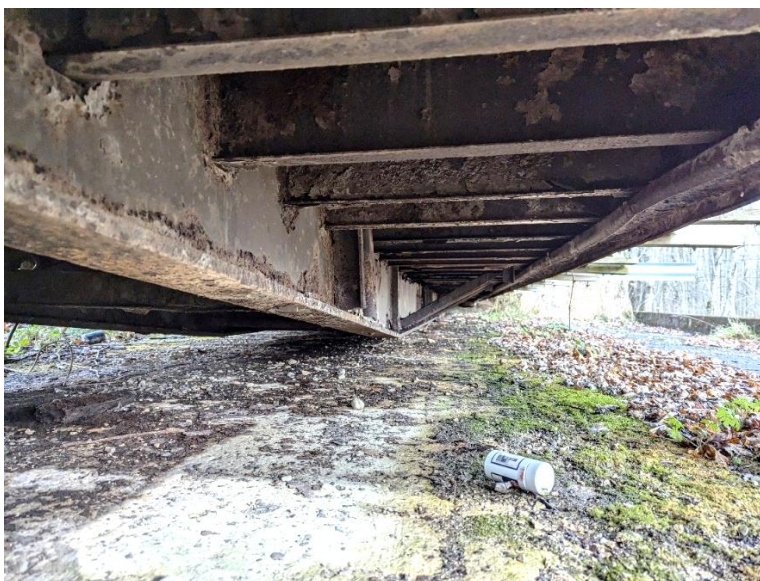
The steel girders appear to be in overall good to fair condition with corrosion noted throughout. The bottom flanges of the girders were noted to have  $\pm 5\%$  section loss. The steel girders have web stiffeners installed in seven (7) locations. In general, the web stiffeners are in similar condition to the girders with corrosion noted throughout and  $\pm 5\%$  section loss near the bottom of the stiffeners.

**Figure 5.1: Eastern Steel Plate Girder**

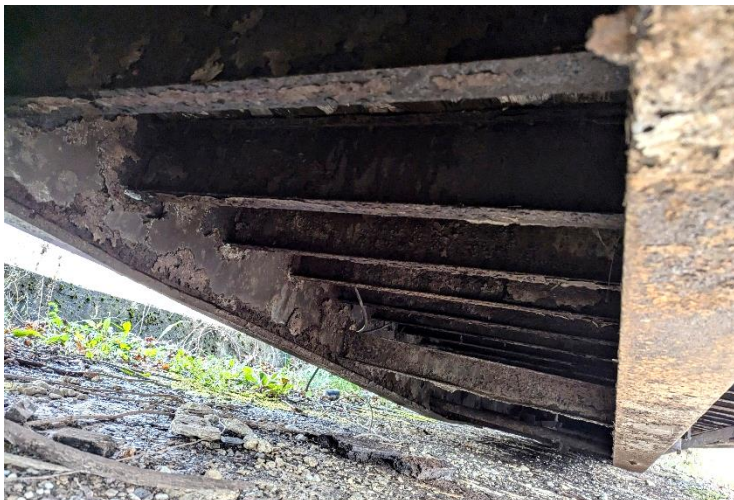
The floor beams appear to be in overall fair condition with moderate section loss noted. Portions of the webs are beginning to flake off with an estimated 25% section loss. The floor beams are 3.2m in length and run continuous across the bridge width (penetrating through longitudinal girders). The W-Shape beams are 152mm in depth with 50mm flange widths and 3.2mm flange thickness. The ends of the floor beams are capped by C-Channels. This load evaluation assumes the floor beams cantilever past both girders and are free on the east and west ends.

Figure 5.2: Typical Floor Beams

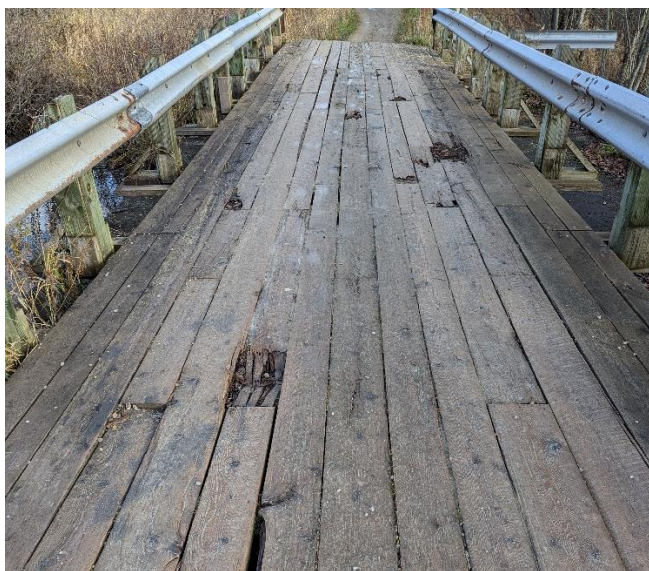
The wooden deck appears to be in overall fair to poor condition. Significant rot and perforations are noted in ten (10) different locations throughout the deck. In general, the wooden deck was soft and beginning to deteriorate (rot) throughout. A previous inspection was completed on this bridge structure in June 2024 by PEARSON for the Biennial OSIM Inspections. Within the last 5 months since the inspection, the condition of the deck has significantly worsened, indicating that the deck has reached the end of its useful service life. It should be noted that minor rehabilitations to the deck had been completed after the review to repair the rotten deck boards.

Figure 5.3: View of Deck Wearing Surface

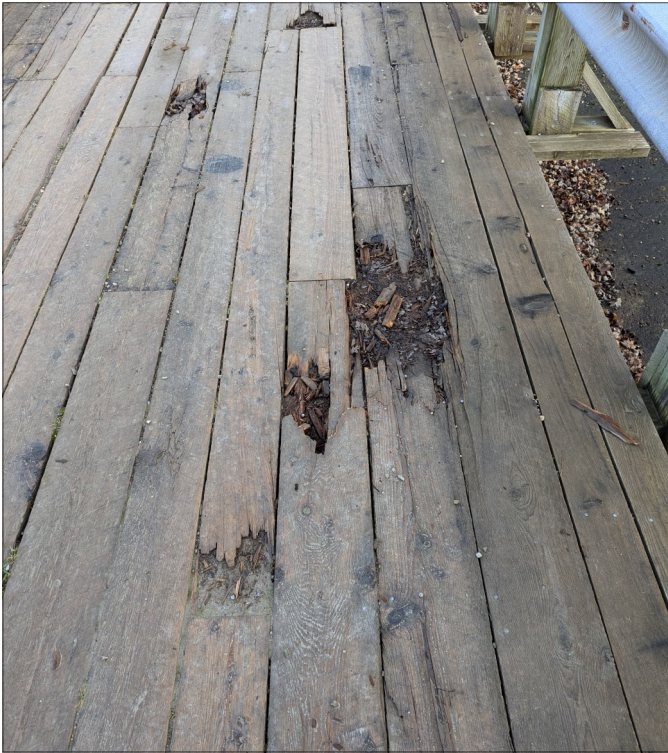
Photo 5 - View of Deteriorated Deck Boards.

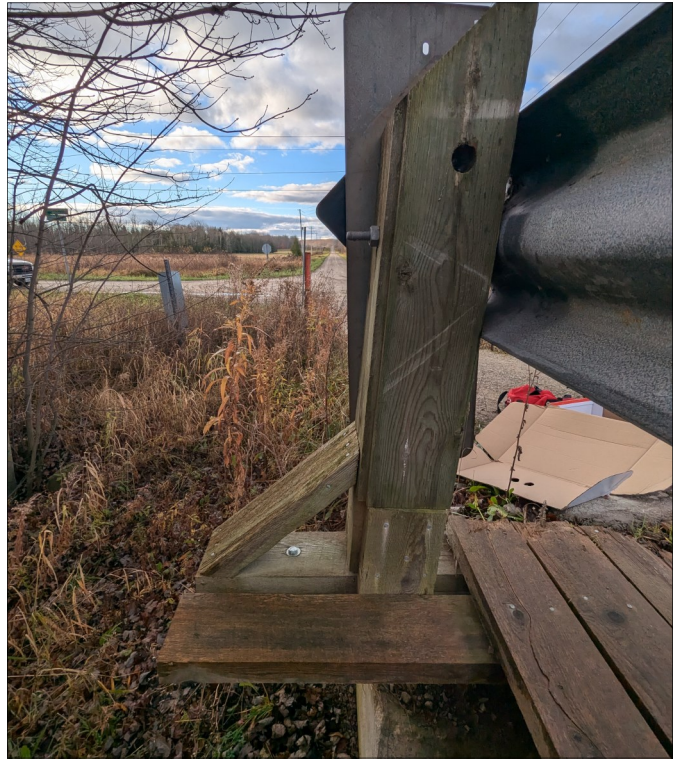
Photo 6 - View of Barrier Post Connection Detail.

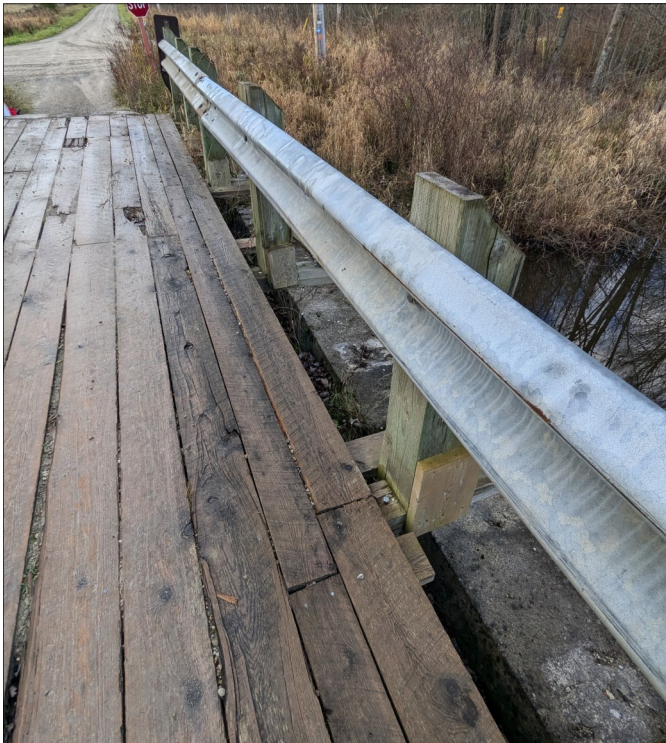
It should be noted that our review did not include an in-depth analysis of the steel beam barrier system. The current configuration for the barrier system is not considered code compliant, and the construction methodology does not appear to have the structural capacity to support the loading requirements (vehicle or pedestrian) outlined in the CHBDC. During the site inspections the barrier system could be laterally displaced with human force, and therefore was assumed to have minimal live loading capacity. Given the fact that the barrier system does not appear to meet the CHBDC requirements, if the bridge is rehabilitated and reopened to vehicular traffic, the barrier system will need to be replaced.

Photo 7 - View of Steel Beam Barrier System.

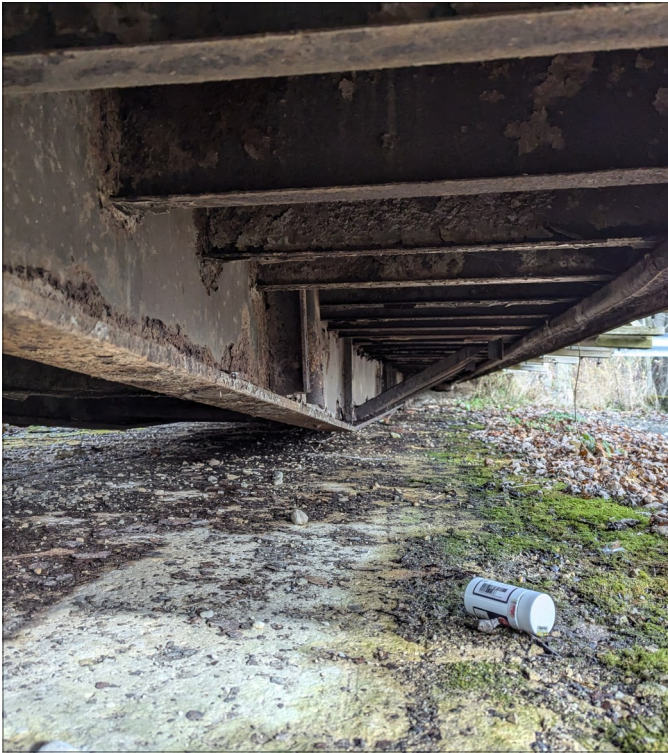
Photo 9 - View of Cantilevered Floor Beams.

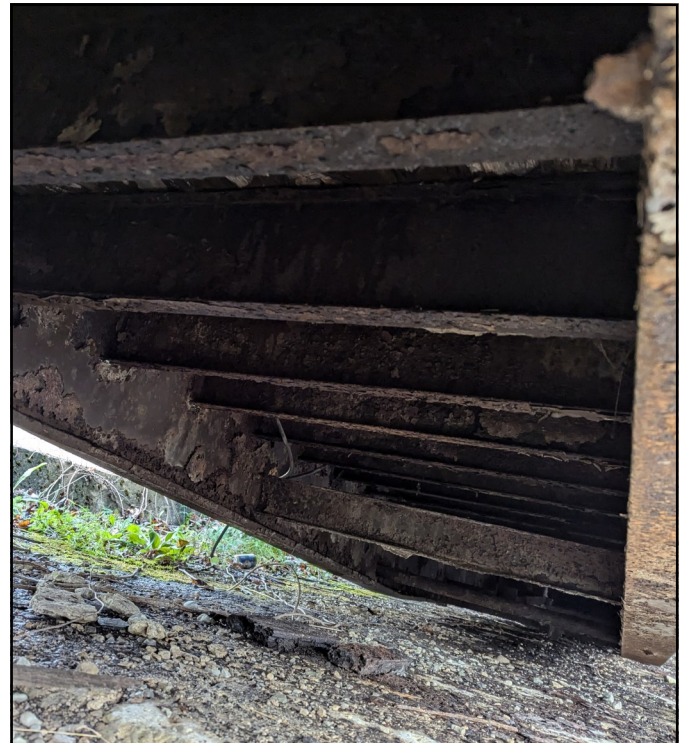
Photo 12 - View of Interior Floor Beams.

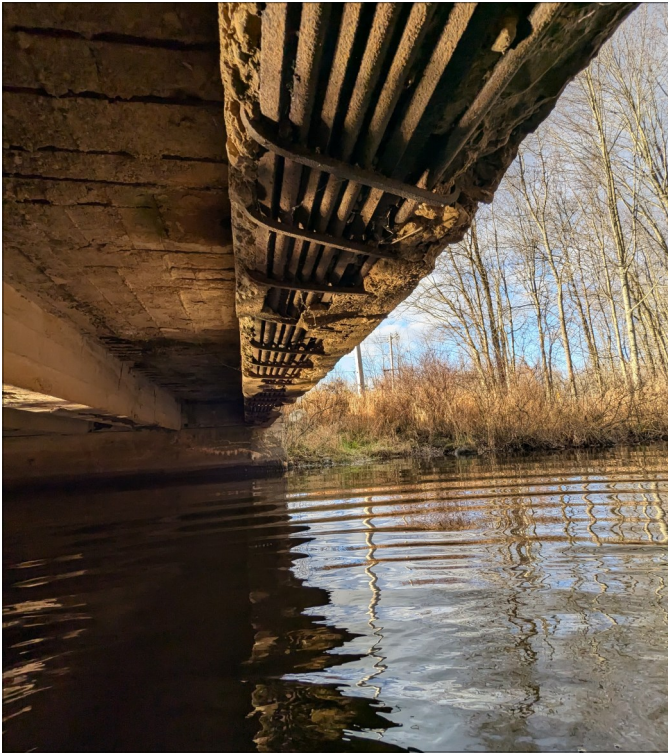
Photo 5 - View of Concrete Structure Girder Deterioration.
