December 12, 2024
Project No. 2408176

**Re: Engineering Support for Lot Severance
Karst Assessment and Letter of Opinion for Bedrock Resource Extraction
156 Mountain Lake Drive, Georgian Bluffs, ON, N0H 2T0, Canada**

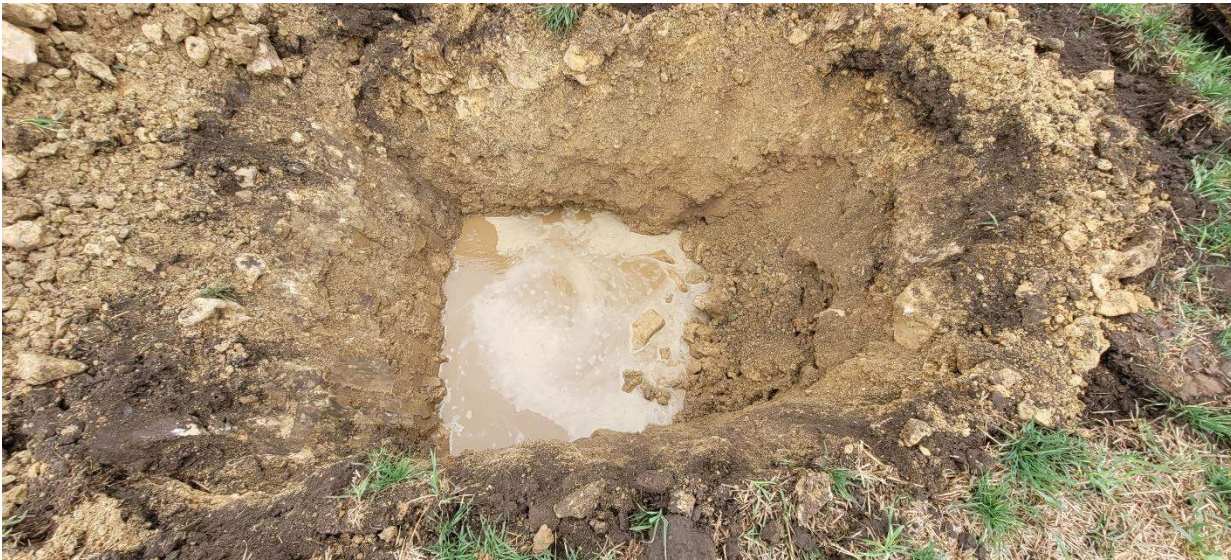
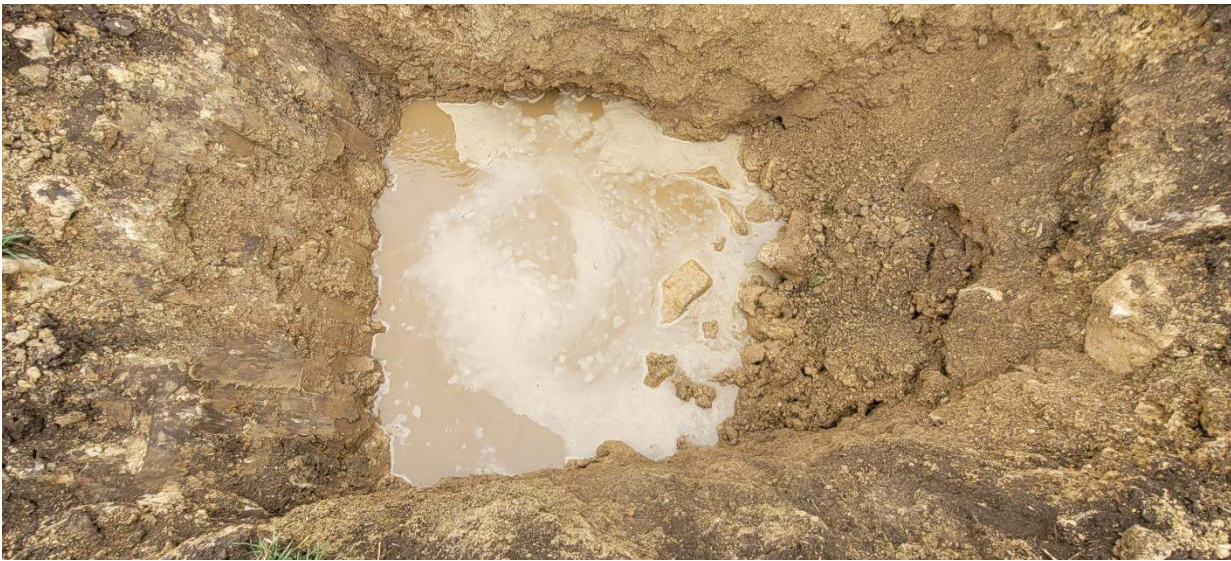
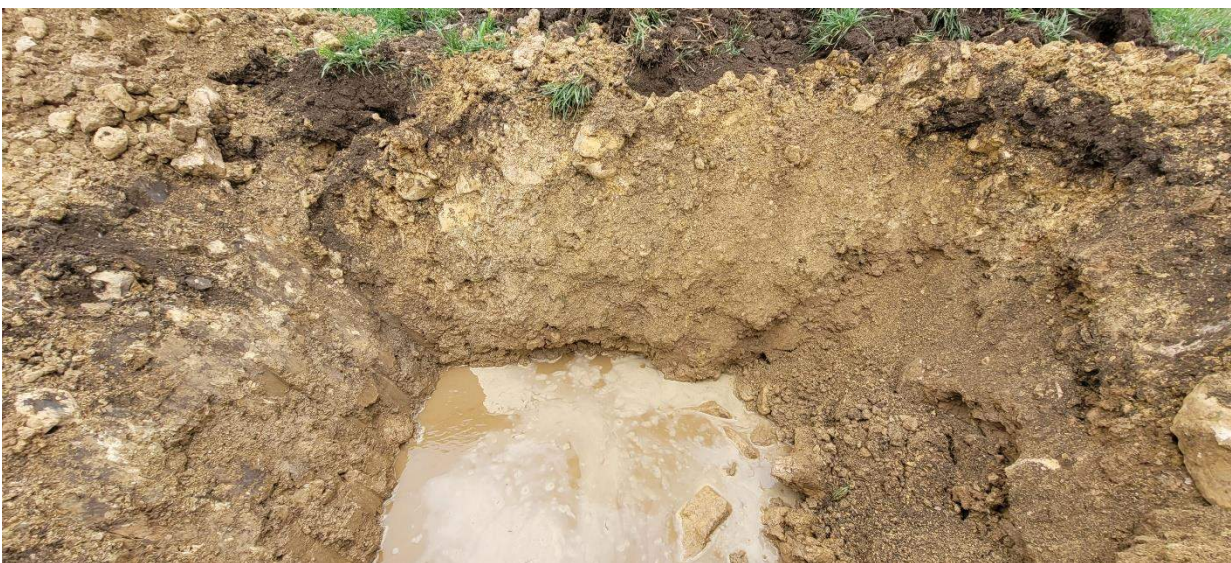
1. In TH01, TH02, TH05, and TH06, bedrock was encountered at depths of 0.57 mbgs, 1.32 mbgs, 1.40 mbgs, and 1.40 mbgs, respectively. The water table was intercepted in all four testholes just above the bedrock / soil contact with the shallowest water table intercepted at 0.50 mbgs in TH01. All four testholes had a similar black organic rich and damp topsoil layer containing silt and clay. A yellow to tan coloured loam followed, containing dominantly silt and clay with minor components of sand and the occasional cobble up to 30cm in diameter. Bedrock was only clearly visible in TH06 due to the slower infiltration rate, and a tan to grey dolostone was identified with no fissile textures, fissures, or major karst features evident.

Picture 1: TH-01 - Overhead view.

Picture 2: TH-01 – Close up view of testhole bottom.

Picture 3: TH-01 – Side view showing soil profile.

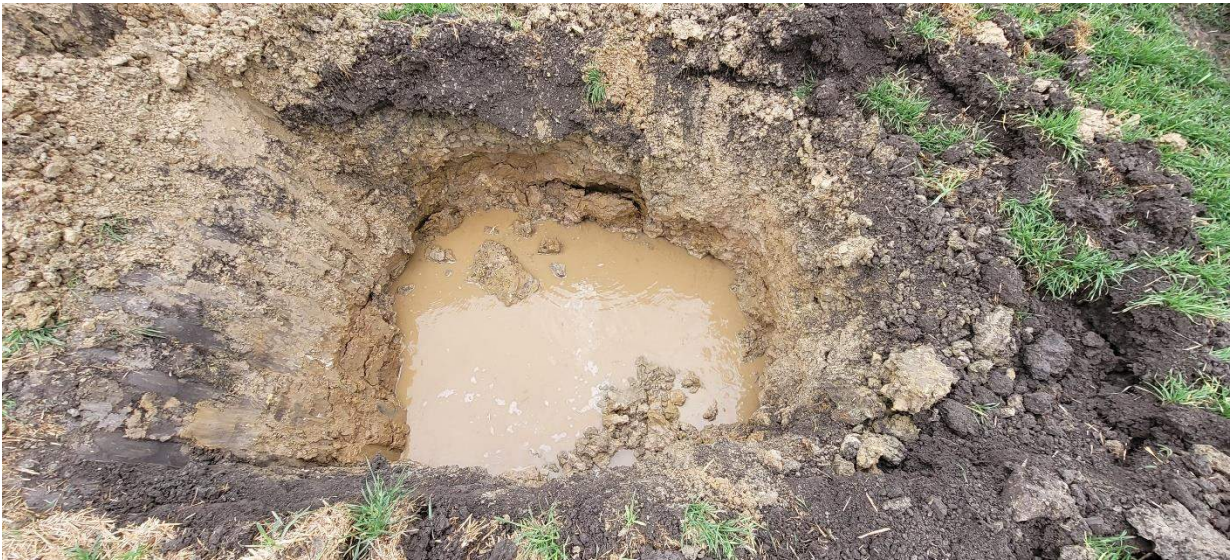
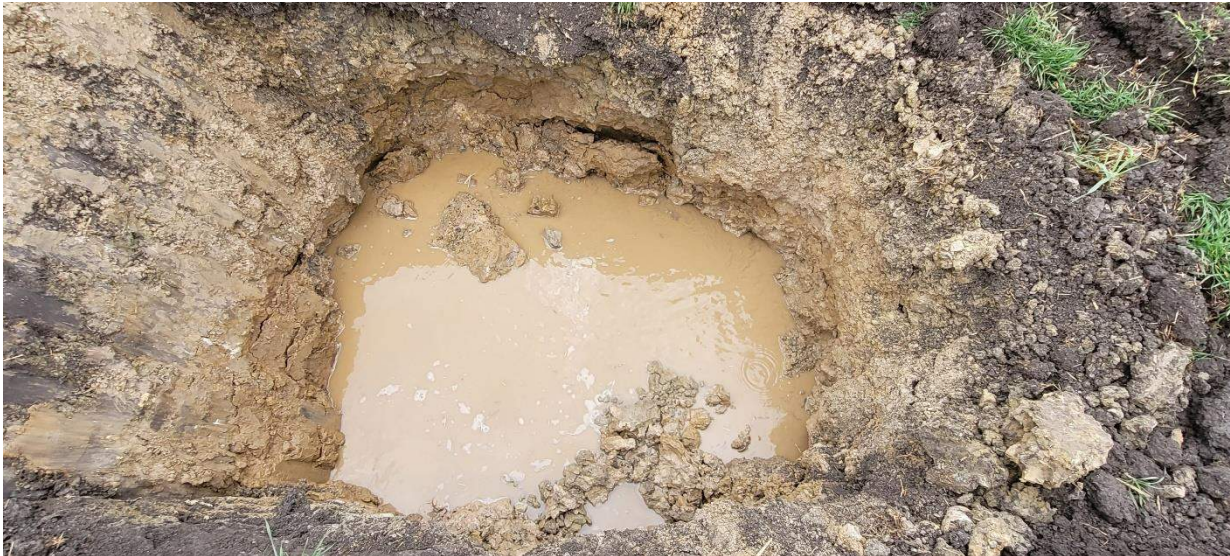
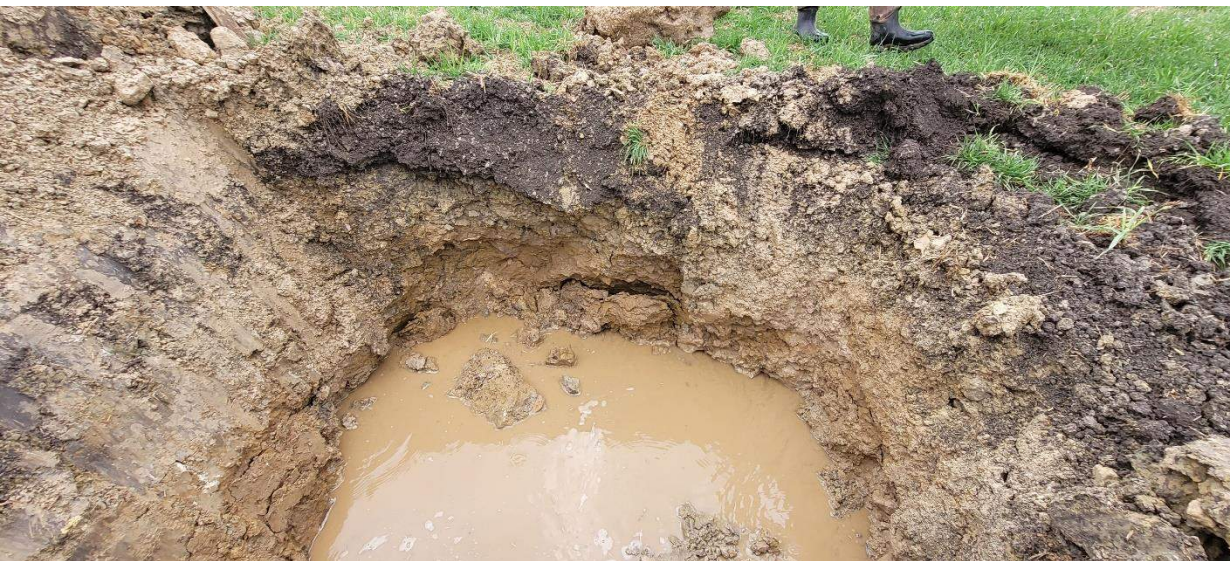
Picture 4: TH-02- Overhead view.

Picture 4: TH-02 – Close up view of testhole bottom.

Picture 6: TH-02 –Side view showing soil profile.

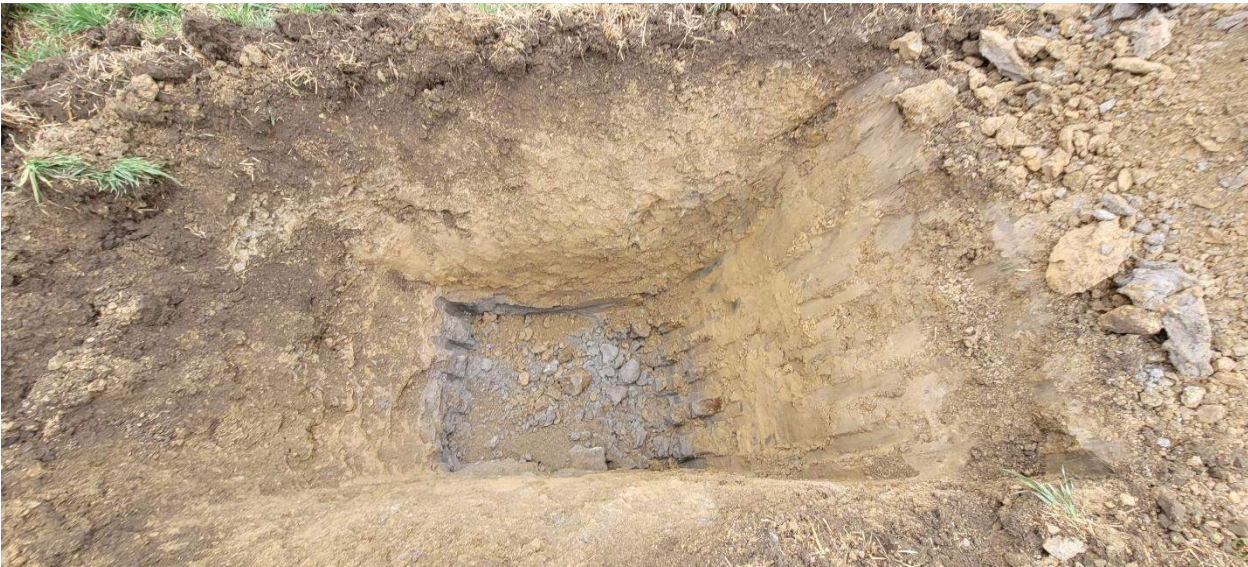
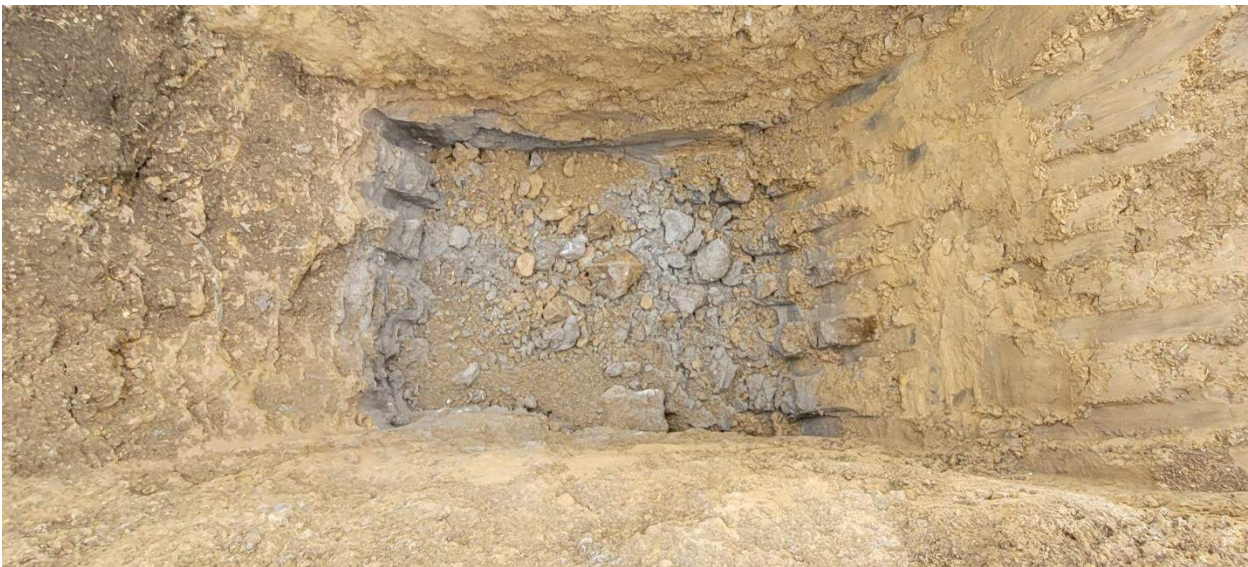
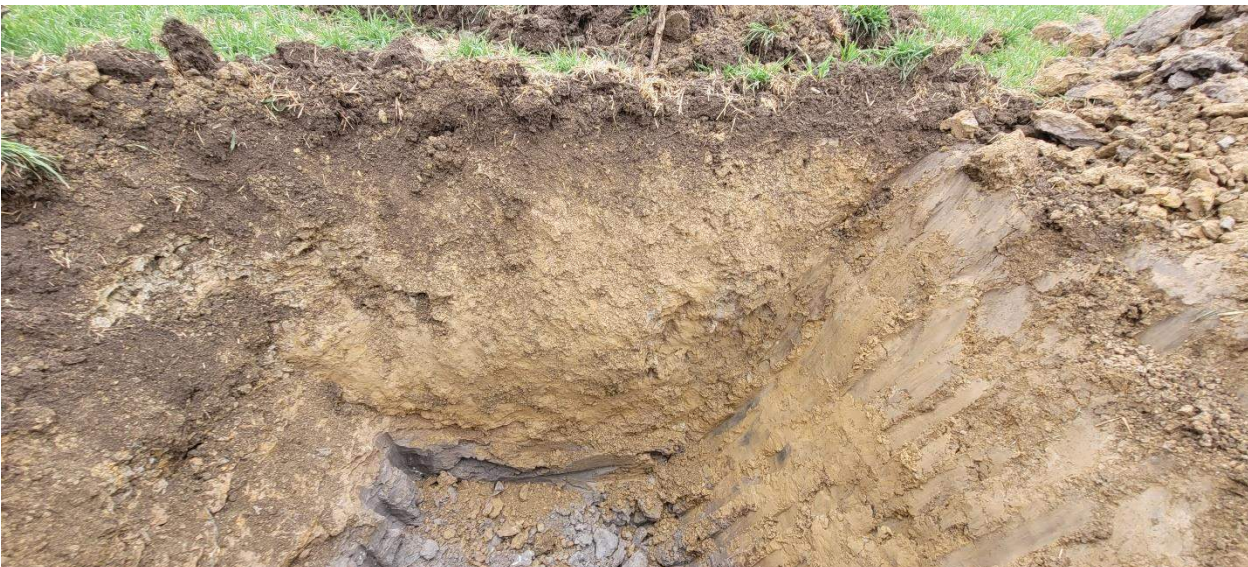
- (b) In TH03 and TH07, bedrock was not encountered and the testholes were advanced to 2.10 mbgs and 2.20 mbgs, respectively. Soil encountered were similar to that of TH04 for both testholes. TH07 had water seeping in through the loam/clay soil interbeds similarly to TH04. TH03 had no loam interbeds within the clay unit, and was massively bedded (homogenous). Initially, TH03 showed no evidence of the water table. However, it was left open during the course of the site visit and was re-visited before leaving Site. During that time, some slumping occurred and water had seeped through the clay unit at approximately 1.85 mbgs, suggesting the soils are in fact saturated but contain a very low hydraulic conductivity.

Picture 7: TH-03 – Overhead view.

Picture 8: TH-03 - Close up view of testhole bottom.

Picture 9: TH-03 – Side view showing soil profile.

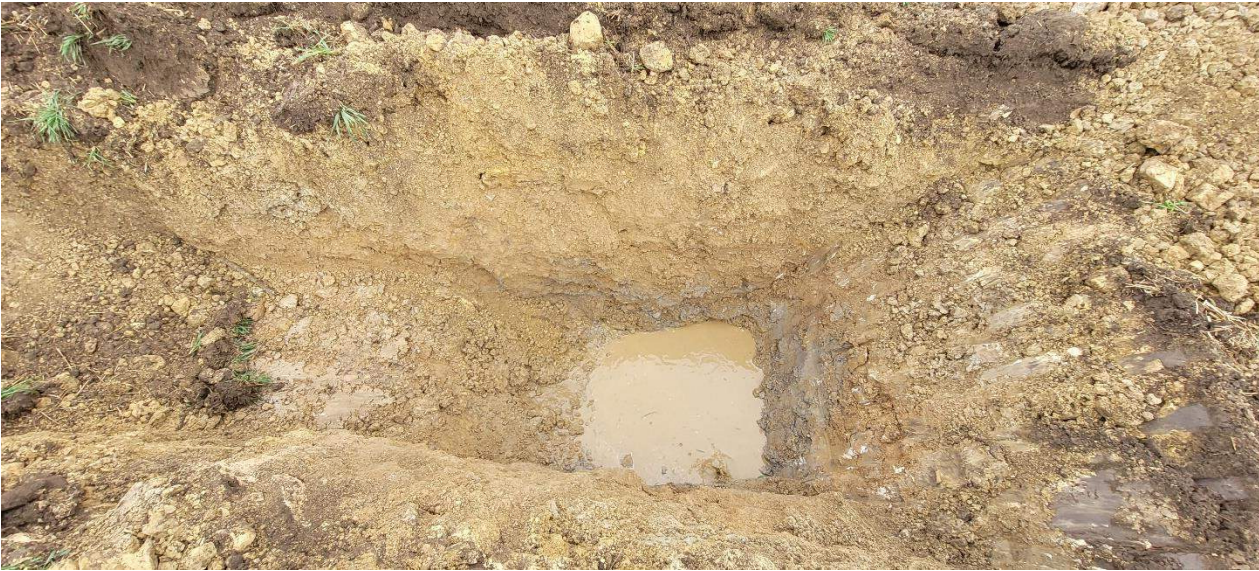
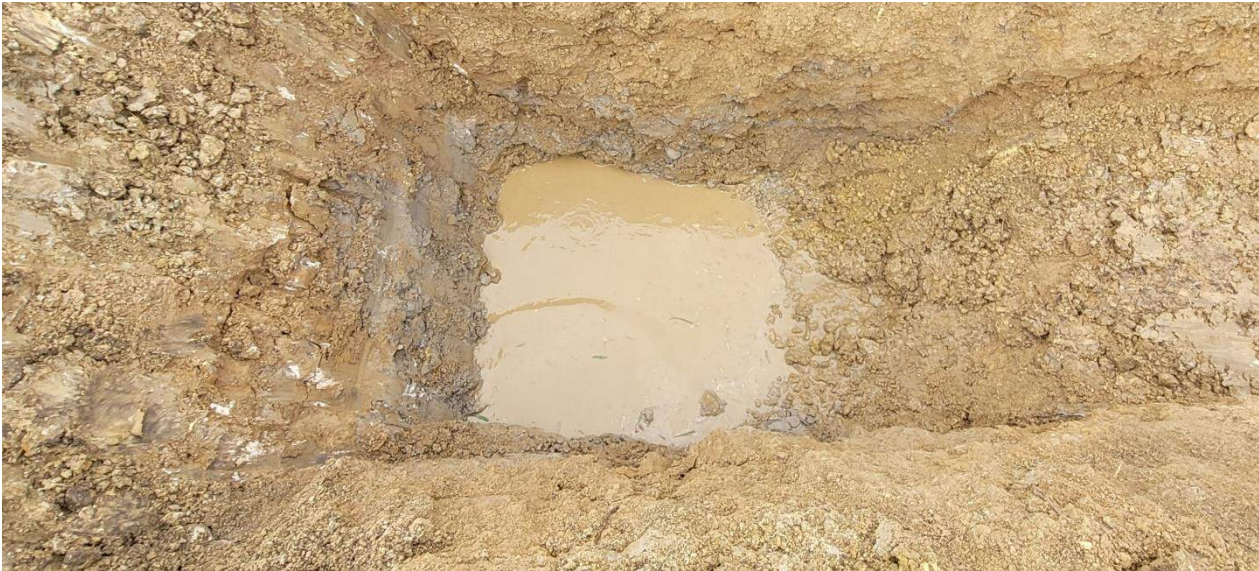
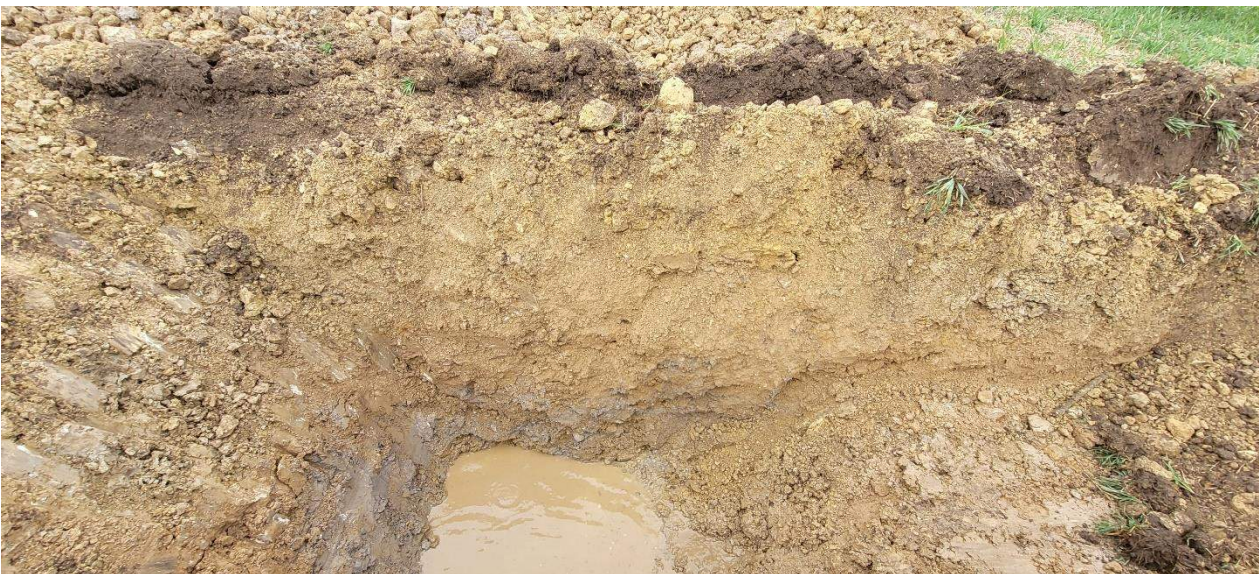
- (a) In TH04, bedrock was encountered at depths of 1.95 mbgs. TH-04 had similar black organic rich topsoil and yellow-tan loam soils to the testholes noted above, but intercepted a hard clay layer at 1.40 mbgs. The clay unit was grey in colour, damp, and contained some interfingering layers of the loam unit above. Water seemed to enter through the thin units of interbedded loam.

Picture 10: TH-04 – Overhead view.

Picture 11: TH-04 - Close up view of testhole bottom.

Picture 12: TH-04 – Side view showing soil profile.

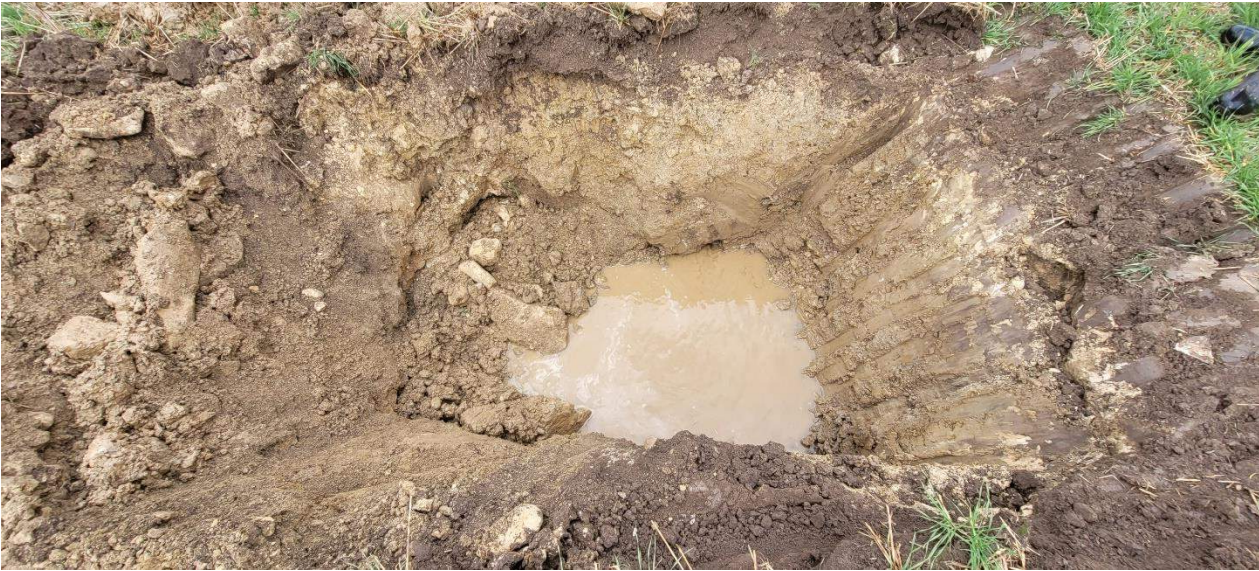
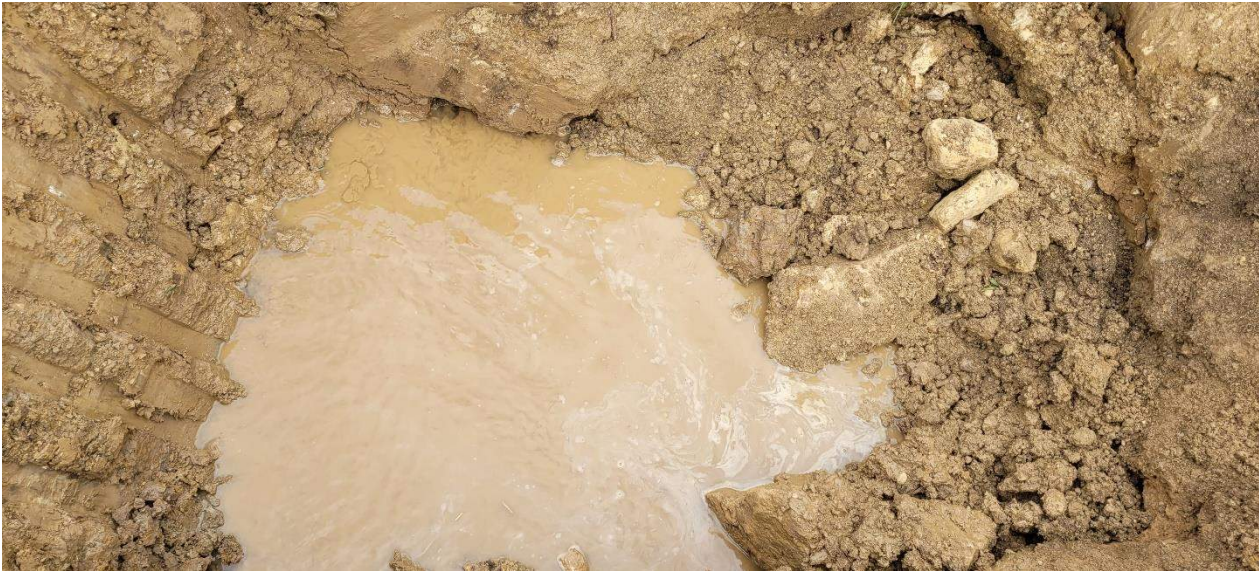
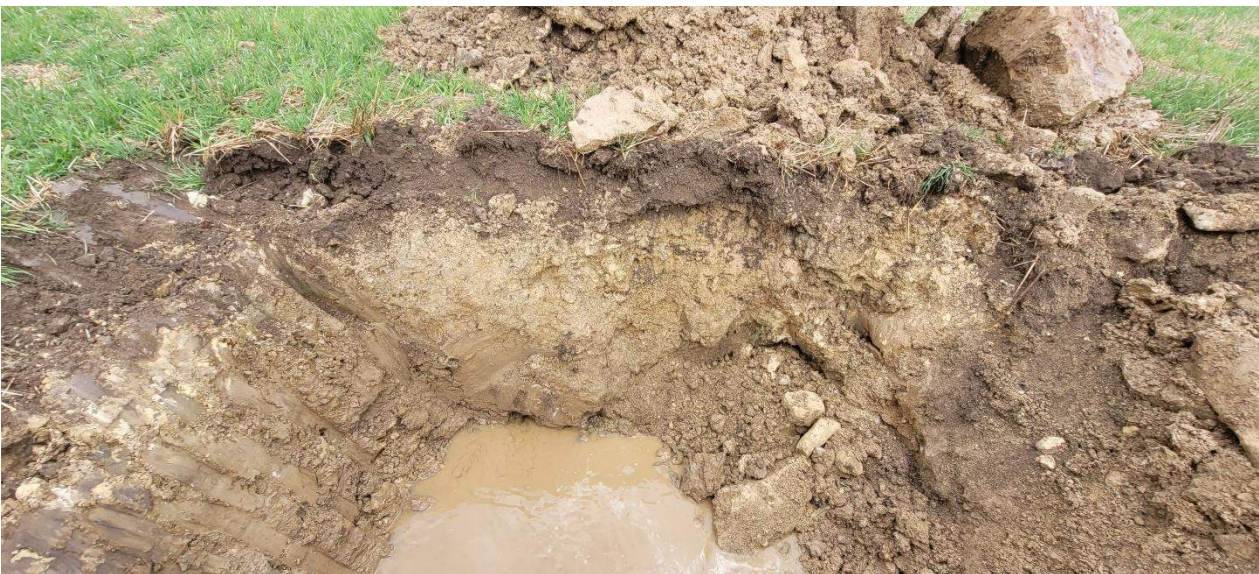
Picture 13: TH-05 – Overhead view.

Picture 14: TH-05 - Close up view of testhole bottom.

Picture 15: TH-05 – Side view showing soil profile.

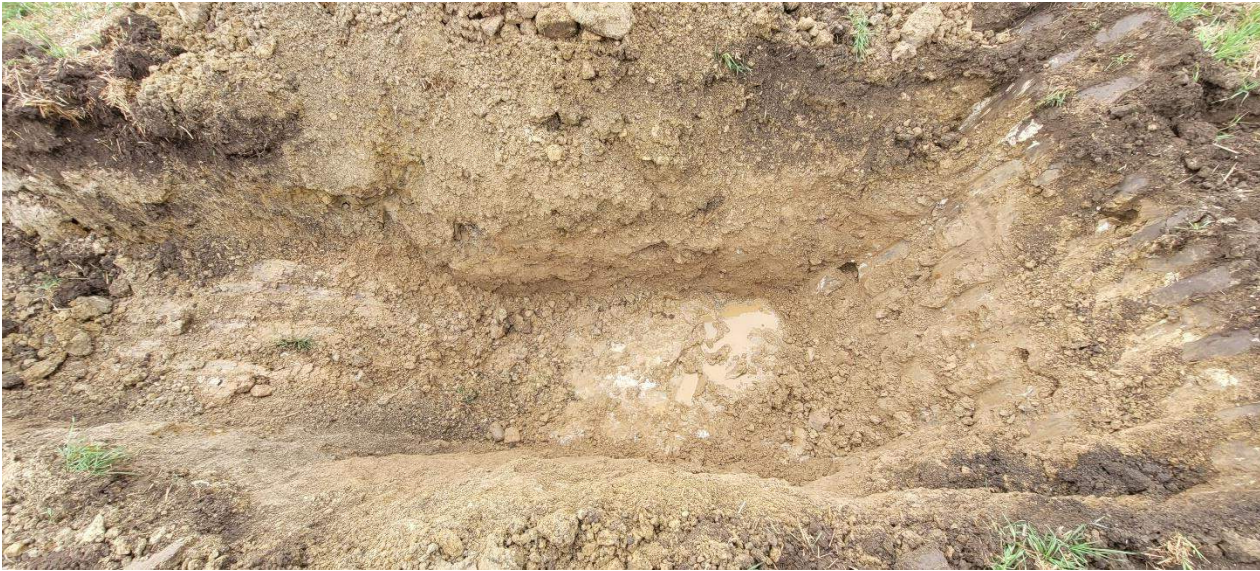
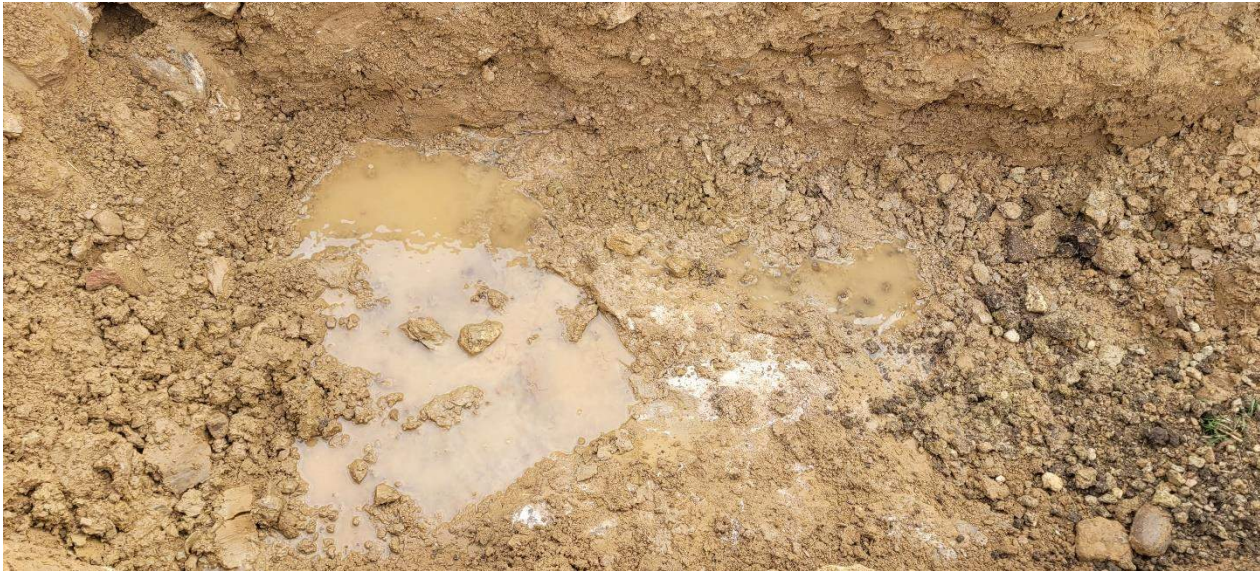
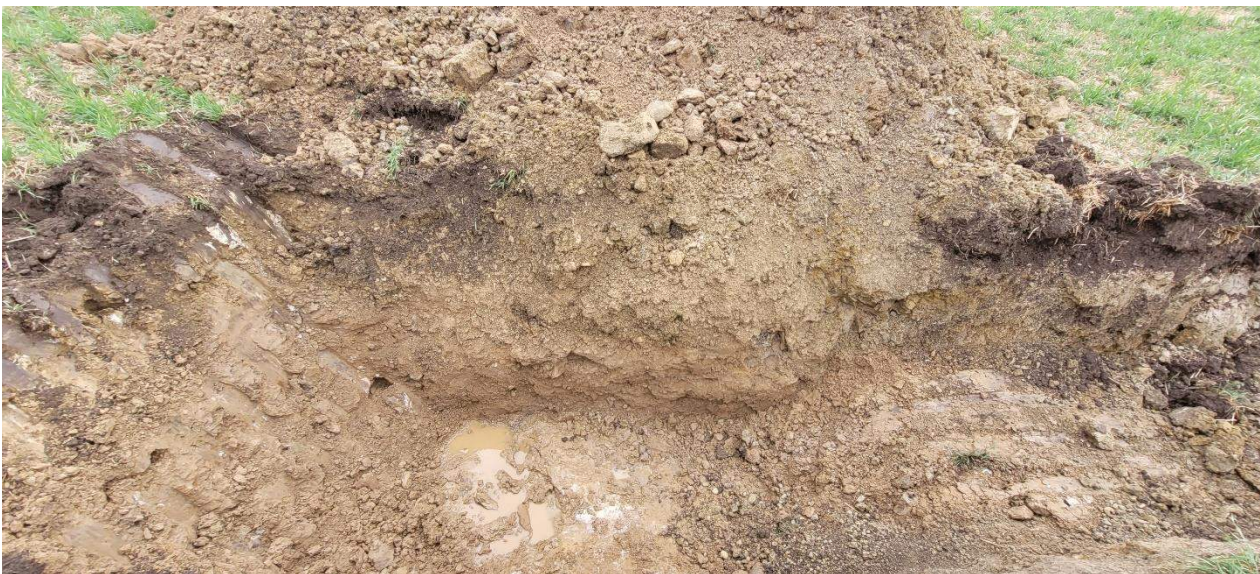
Picture 16: TH-06 – Overhead view.

Picture 17: TH-06 - Close up view of testhole bottom.

Picture 18: TH-06 – Side view showing soil profile.

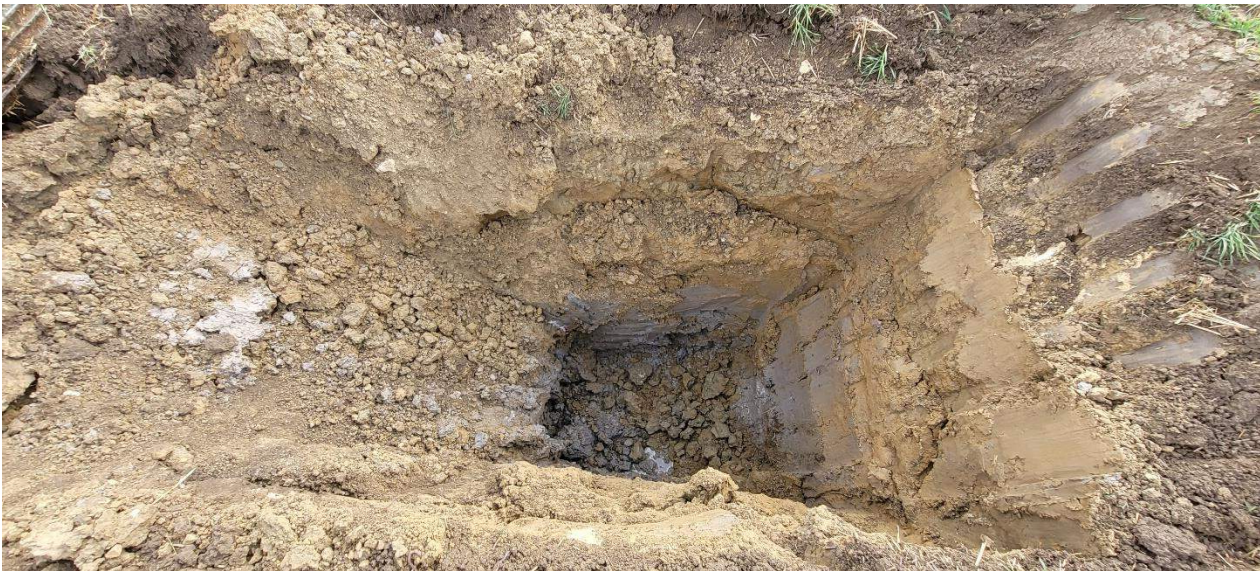
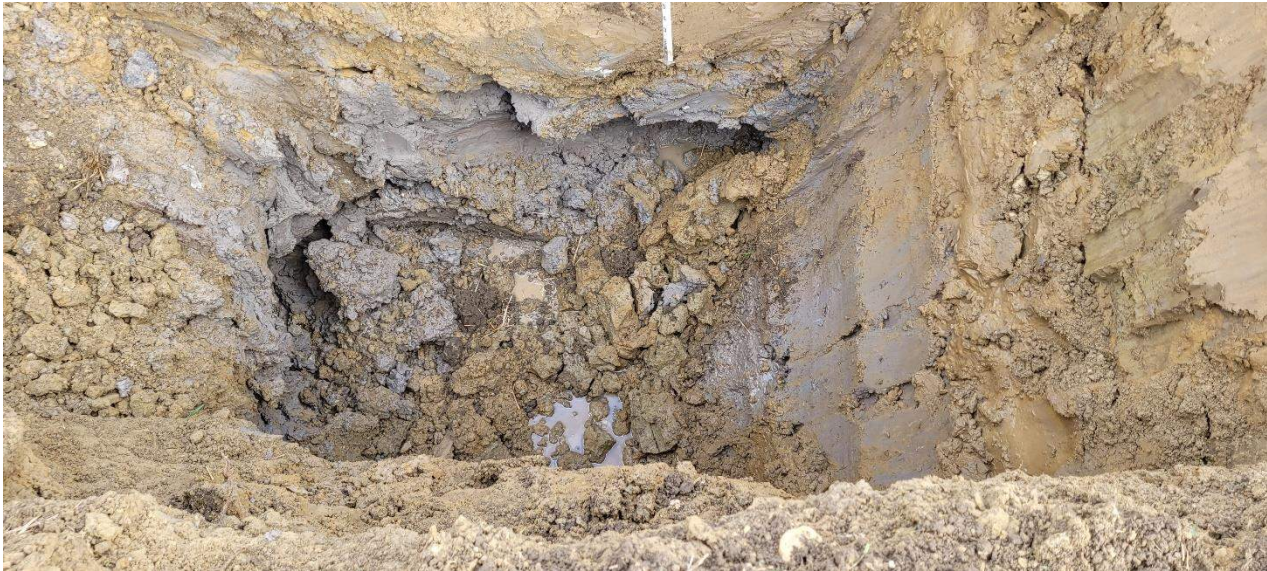
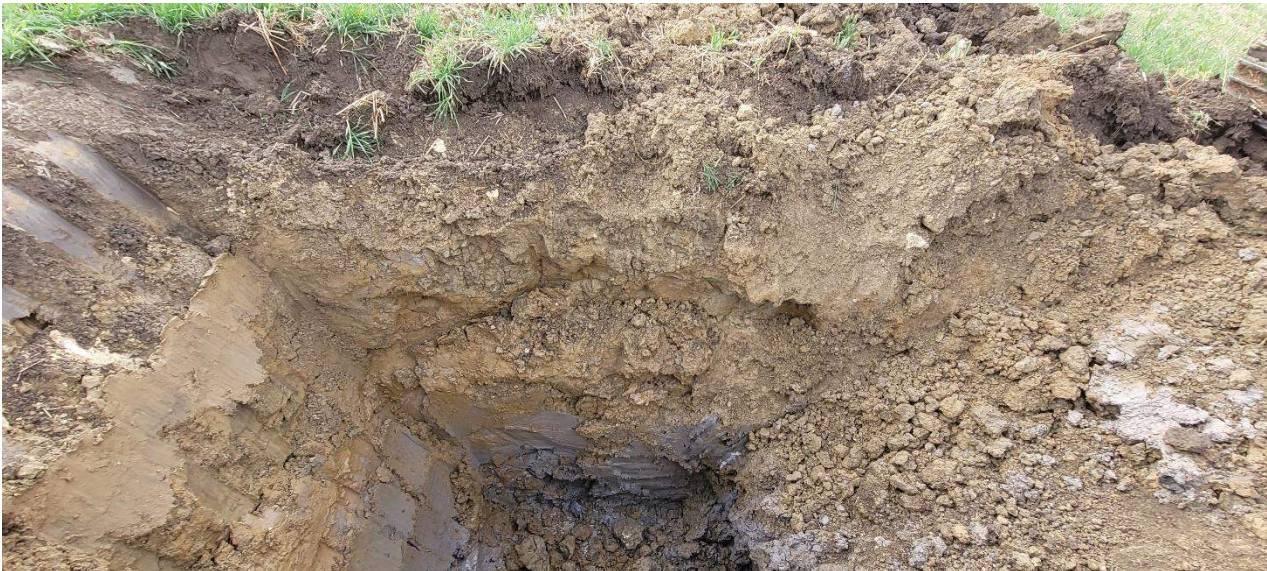
Picture 19: TH-07 – Overhead view.

Picture 20: TH-07 - Close up view of testhole bottom.

Picture 21: TH-07 – Side view showing soil profile.

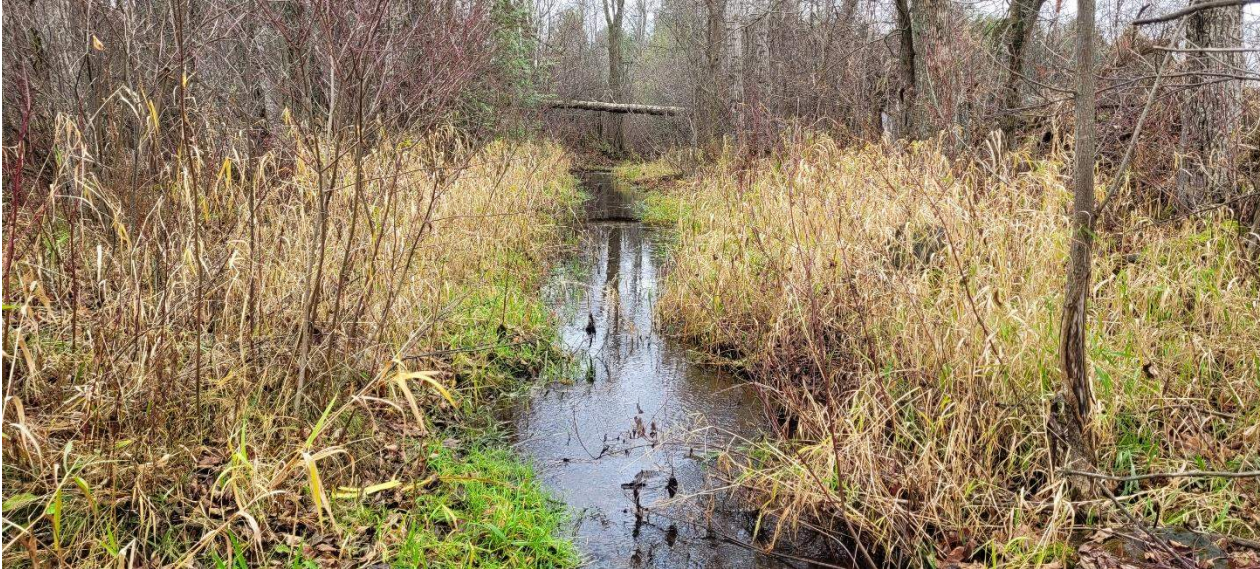
Picture 23: Showing the creek to the west of the property.
