DESIGN ALTERNATIVE ASSESSMENT

STRUCTURE S-0005 SARAWAK KEPPEL TOWNLINE

> TOWNSHIP OF GEORGIAN BLUFFS COUNTY OF GREY

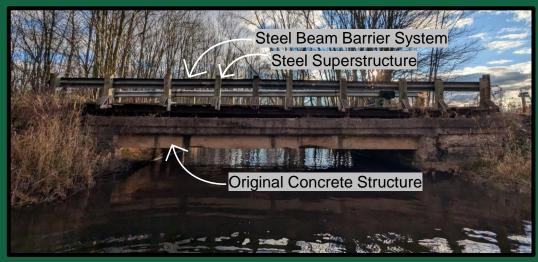
The existing load carrying superstructure of the bridge utilizes a steel frame of a flatbed trailer, which spans 14.1m over an existing concrete T-beam bridge (original structure). The concrete T-beam bridge spans 9.3m and conveys water flow for the Indian creek. The original structure was previously owned by Grey County until it was purchased by the Township in 2015/2016. After purchasing the structure, the steel superstructure was installed over the original bridge to allow the roadway to remain open.

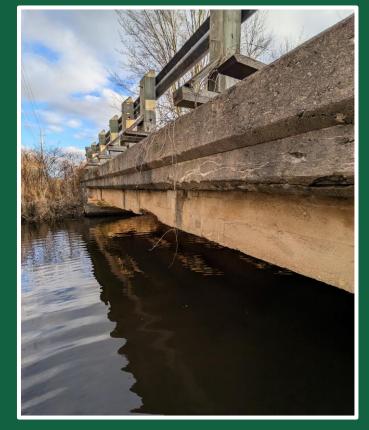
View of East Exterior Soffit and Curb

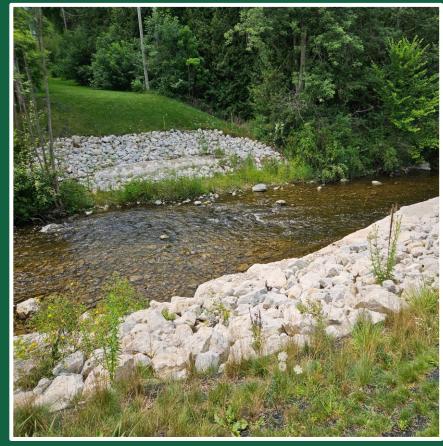
Photo example from Orchardville Bridge
