Re: Karst Topography Assessment  
102759 Grey Road 18,  
Rockford, ON  
Township of Georgian Bluffs

This letter report provides the findings of the Karst Topography Assessment that was conducted on the property identified as 102759 Grey Road 18, located in the former Township of Derby, Township of Georgian Bluffs, in the County of Grey. The subject property currently contains a single residential dwelling with an attached garage. The majority of the property is primarily cleared with treed areas in the central and northern portions of the property. No municipal sanitary sewer or water services are provided to the property.

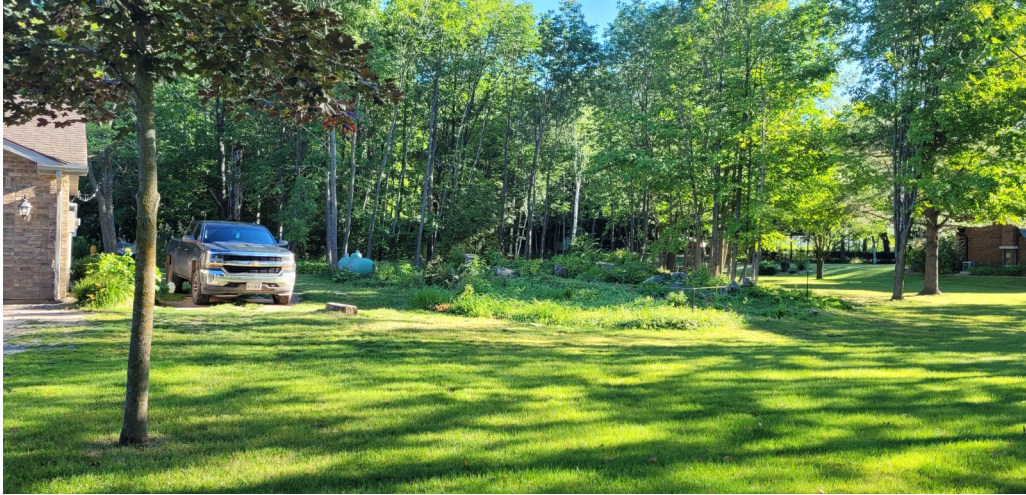
The surface in the study area was observed to be consist of a large garden with some decorative bedrock derived boulders at surface. It is our understanding that the area proposed for development has been historically used for residential use. As discussed, the general layout of the area of proposed development is presented in Figure 2.

**Photo 1:** Area of proposed onsite detached garage building east of the existing dwelling on the subject property.

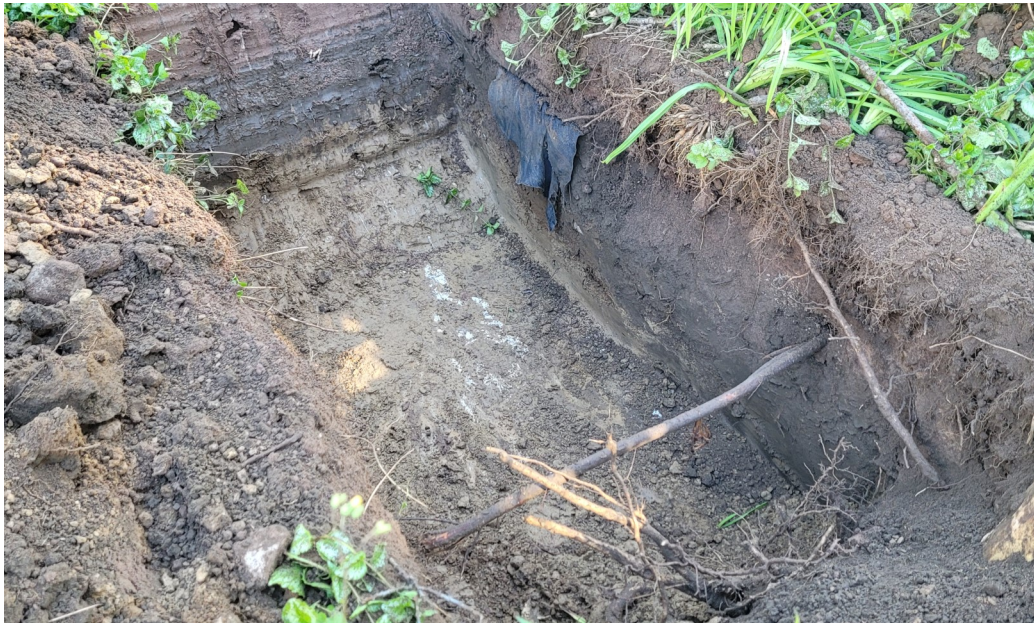
In the testholes, the bedrock was encountered between approximately 0.3 and 0.85 mbgs. The native soil overlying the bedrock in each of the testholes generally consisted of compact silt and sand to the bedrock surface. It is noted that a layer of organic soil was encountered in TH-1 between 0.45 and 0.65 mbgs, which was underlain by sandy silt soils to the bedrock surface.

Although the bedrock encountered in each of the testholes was generally weathered and hummocky, no significant fractures or evidence of karstic or epi-karstic features were observed (i.e. open or soil-infilled fractures). Photographs of the Site and the testholes are attached for reference.

**Photo 2:** View of bedrock surface in TH-1

1. That at the time of construction, the bedrock surface be inspected in areas where it is exposed to confirm the nature of the bedrock and the presence or absence of any fractures or dissolution features that would pose structural limitations. Should fractures or crevasses be uncovered during site preparation for foundations, additional support or adjustments to the foundation design may be required. We recommend that such a review be completed by a qualified person (as per the OBC).
2. Development of the property beyond the limits of the proposed development would be subject to further study and inspection prior to approval.

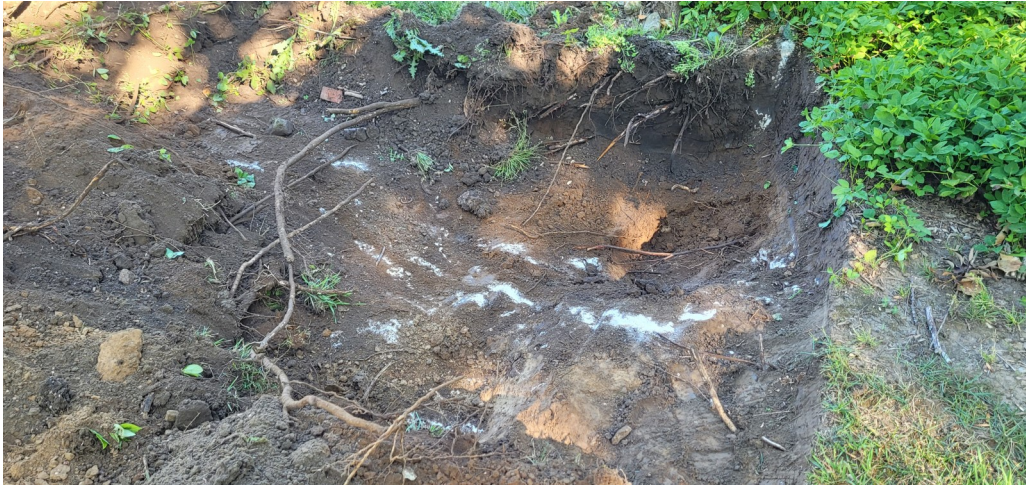
**Photo 3:** View of weathered, hummocky bedrock surface in TH-2.

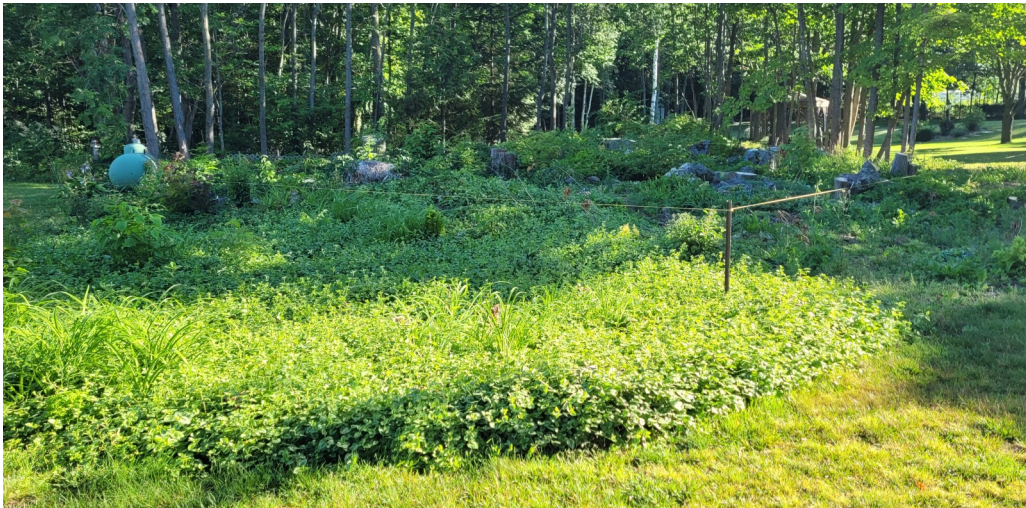
Based on the onsite observations at the time of the investigation, no significant depressions, areas of subsidence, groundwater springs, or seeps were observed in the vicinity of the study area, or across the rest of the property that would suggest shallow hydraulically active karstic bedrock features. A small, flat surface bedrock outcrop was observed on the south extent of the area of proposed development.

**Photo 4:** View of approximate location of proposed detached garage structure.
