Re: Karst Topography Assessment
Concession 14/15, Lot 24 and Part Lot 23
Township of Georgian Bluffs

222360
Karst Topography Assessment
Concession Road 14
Township of Georgian Bluffs

**Karst Topography Assessment
Concession Road 14 — Municipality of Georgian Bluffs
Estate of Muriel McCrabb**

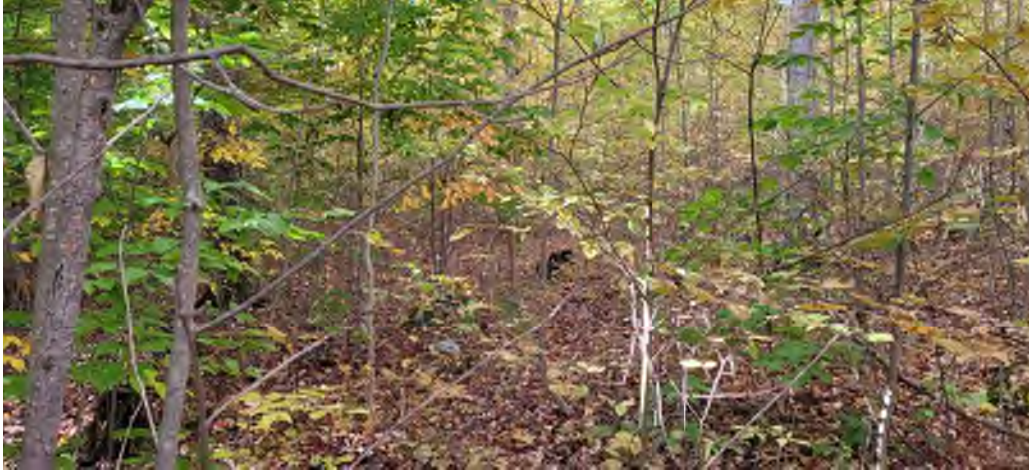
Photo 1: View of area of proposed development on Lot 1.

As part of the field investigations, a series of six (6) testholes were excavated by Chet Ashcroft Excavating (the excavation contractor) for inspection by the undersigned during the site investigation. It is noted that since proposed severance Lot 1, adjacent to the south side of Big Rock Road, is not situated within the Grey County Karst Policy Area and no evidence of hydraulically active karst features were observed across the surface of this Lot, no investigative testholes were excavated on Lot 1.

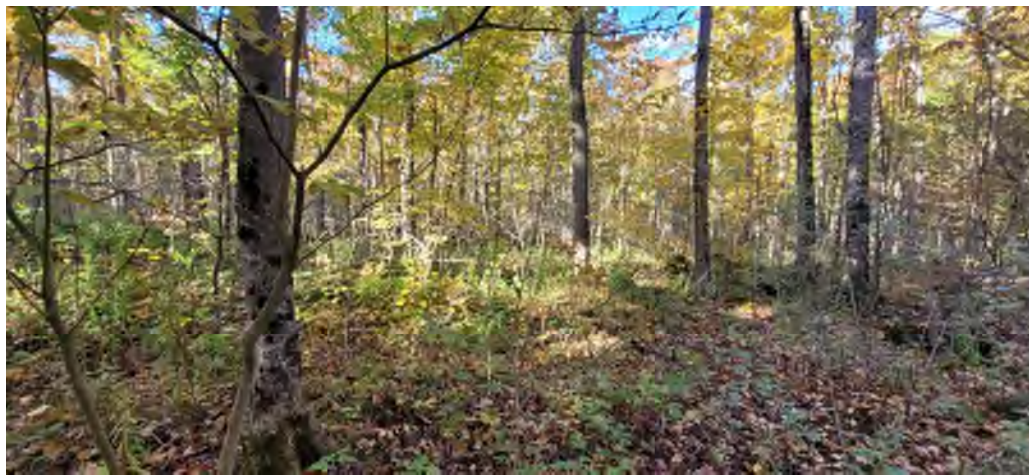
Photo 2: View of area of proposed development on Lot 2.

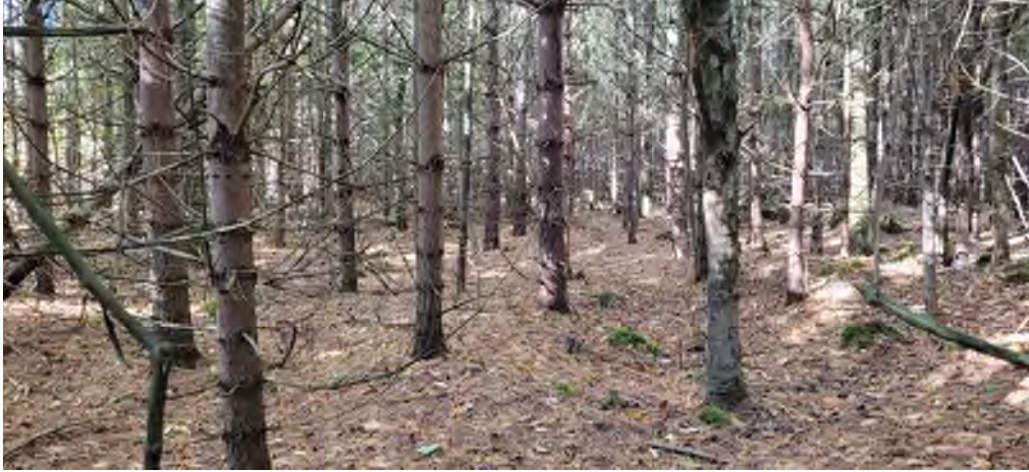
Photo 3: View of area of proposed development on Lot 3.

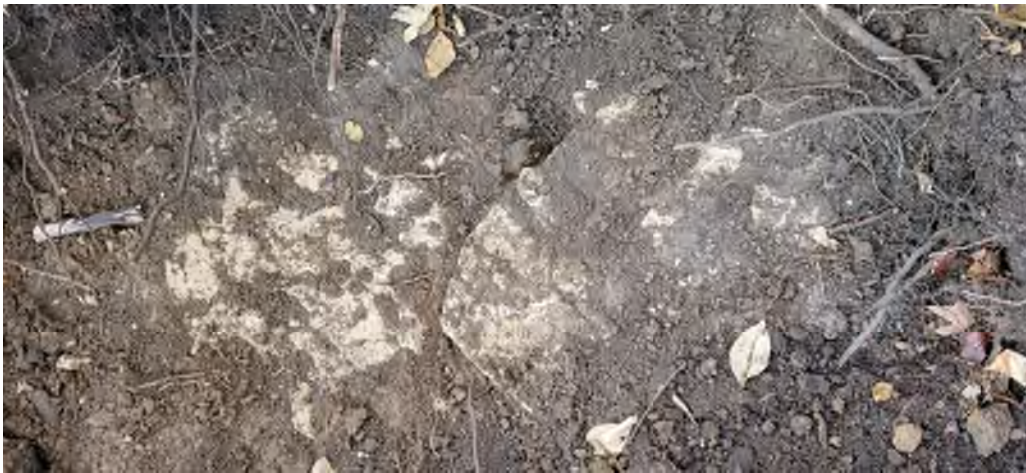
The bedrock in TH-4 and TH-6 was observed to consist of generally flat and competent tan-coloured dolostone bedrock of the Amabel formation. The bedrock in TH-5 appeared to have a more weathered and hummocky surface and a minor fracture with a width of approximately 2 to 4 cm in width was found, which was tightly infilled with silt, clay, and organics.

Although this fracture suggests the potential presence of other similar karstic fractures in the area that may have historically been hydraulically active (i.e. in geologic history), the presence of tight soil within the fracture indicates that it is not active and is considered to be an epi-karst feature.

Photo 4: View of bedrock surface in TH-5. Note soil-infilled epi-karst fracture.

Based on the findings of this investigation, there is no evidence of hydraulically active karst features in the areas proposed for development that would cause a direct risk to the proposed development. Further, no evidence of epi-karst (i.e. geologically historically active karst features) were observed in the testholes or across the surface of the Study Area with the exception of the bedrock observed in the location of TH-5 on Lot 2, where a soil-infilled epi-karstic fracture was observed.

1. That at the time of construction, the bedrock surface be inspected in areas where it is exposed to confirm the nature of the bedrock and the presence or absence of any fractures or dissolution features that would pose structural limitations. Should fractures or crevasses be uncovered during site preparation for foundations, additional support or adjustments to the foundation design may be required. We recommend that such a review be completed by a qualified person (as per the OBC).
2. That any onsite sewage systems are not constructed on areas with evident karstic features (if encountered) and within the proposed development area identified on Figure 2.
3. That the standard separation requirements developed under the Ontario Building Code for site servicing are considered sufficient to support the construction and mitigate the potential for undue impacts.

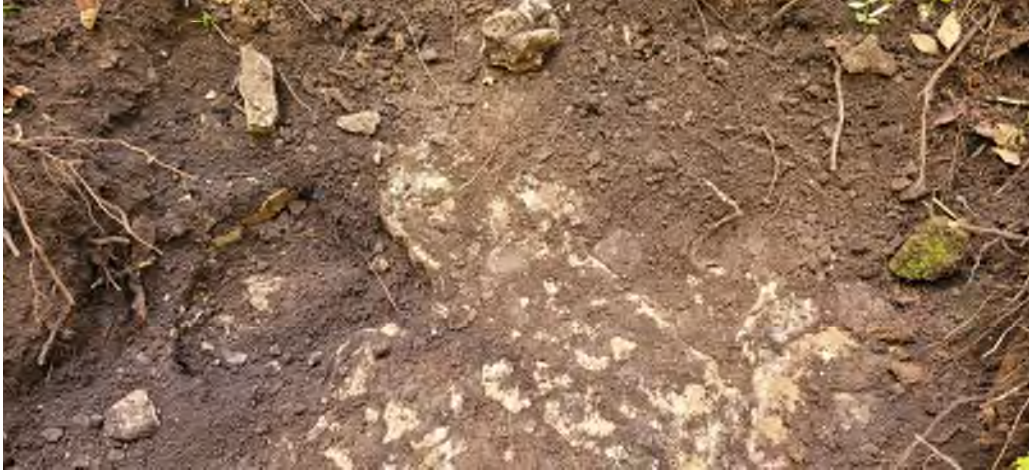
The bedrock was encountered between 0.3 and 0.8 metres below ground surface (mbgs) in the testholes, with the bedrock appearing to be shallower toward the west side of the building envelope (i.e. TH-6). The native soil overlying the bedrock in each of the testholes generally consists of a stony loam (i.e. silt and sand with gravel, cobbles, and boulders with trace clay).

Photo 5: View of bedrock surface in TH-6.

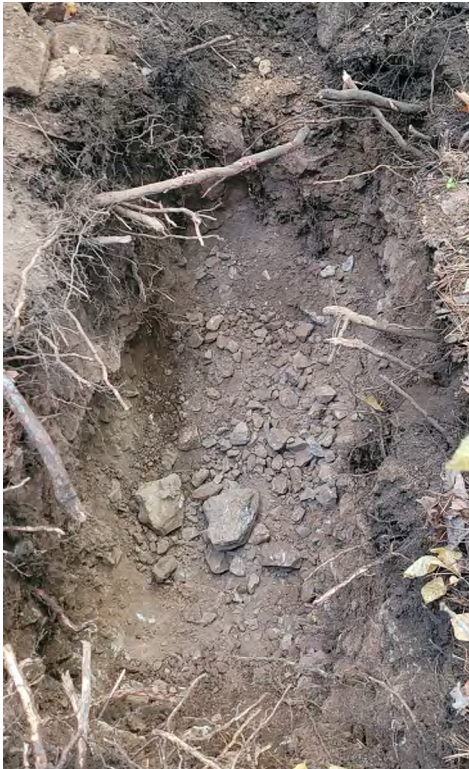
The bedrock was encountered between 1.3 and 1.5 metres below ground surface (mbgs) in the testholes. The native soil overlying the bedrock in each of the testholes generally consists of a similar soil as that encountered on Lot 2, but with a higher boulder content.

The bedrock in was observed to be generally heavily weathered, with the excavator able to “pluck” the less competent upper layers of bedrock. However, no evident fractures or other indication of karst or epi-karst features were specifically observed in each of the three testholes excavated on Lot 3.

Photo 6: View of bedrock surface in TH-1.
