Summary Action Report

Structure ID: K-0021

Road Name: Kemble Rock Road

Structure Type: Double CSP Culvert

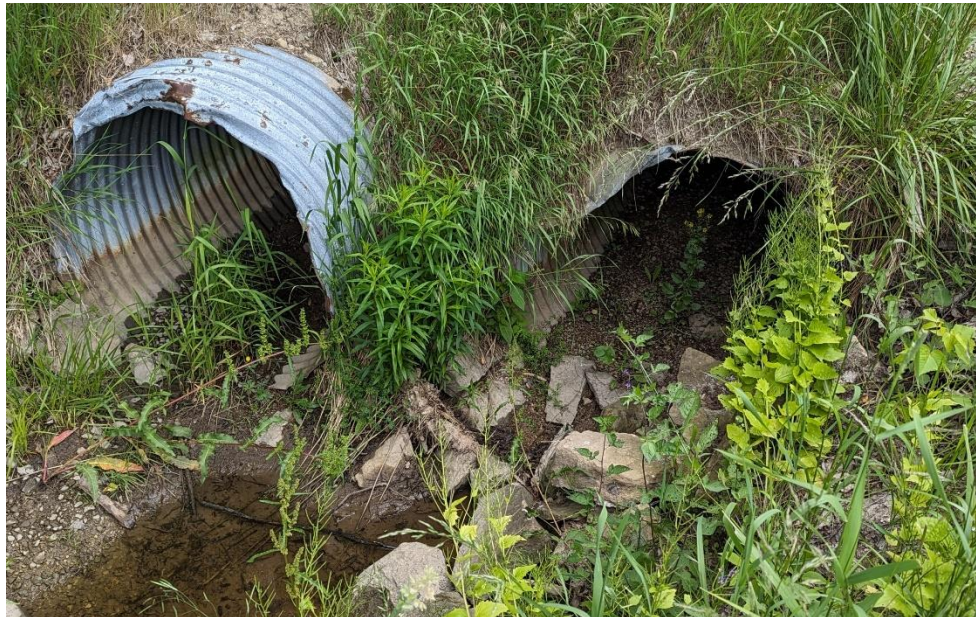
Due to the overall size and location of this structure, the culverts have been included in the Municipality's inventory in 2024. The culvert barrels appear to be in overall poor condition with major section loss at inverts, separation at barrel joints and deformations at the obvert noted throughout. Due to the severe deterioration of the culvert inverts, replacement is recommended within 1 year to ensure the performance of the roadway and the safety of the public.
